Hurricane wind performance and mitigation strategies for informally constructed houses in Puerto Rico

Diego N. Valdivieso,¹ Abbie B. Liel, F.ASCE, P.E.,² and Amy Javernick-Will, M.ASCE³

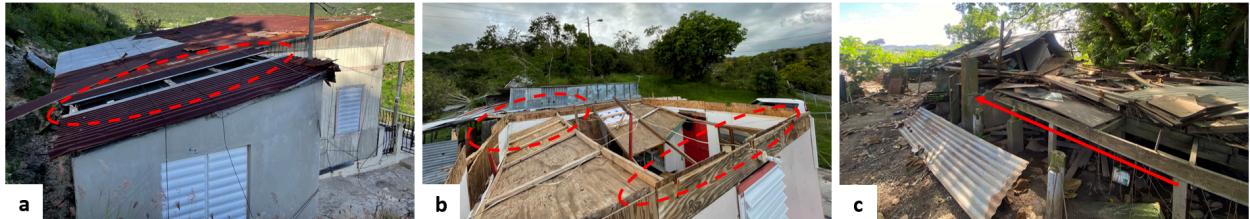
Figure 1. Damage photos showing (a) roof envelope, (b) roof-to-wall connection, and (c) sliding failure modes after Hurricane Maria (2017). Photos: Emily Alfred, Protechos.

Puerto Rico has experienced several devastating hurricanes over the last 30 years, including Hurricanes Hugo, Georges, Irma, and Maria, which have damaged or destroyed thousands of houses and infrastructure (see Figure 1), disrupted communication and electricity, and led to significant loss of life (Enterprise 2019). Wooden houses with corrugated galvanized iron (CGI) roof panels have been particularly vulnerable. The most recent major hurricane was Hurricane Fiona in September 2022. The majority of recovery efforts post-hurricane in Puerto Rico and elsewhere have been initiated and financed by households themselves, i.e., self-recovery, and a better understanding of how to support self-recovery that reduces disaster vulnerability is needed (Opdyke et al. 2021). Researchers have called for additional studies on perceived risks and how they relate to mitigation and resilience building to intervene and improve housing safety (Goldwyn et al. 2022; Cruzado et al. 2018).

pressure or projectile impact (Li et al. 2009). These are also the most common failure modes experienced in wood-frame construction in Puerto Rico in recent hurricanes (Figure 1).
