## FULL-SCALE SHAKE TABLE TEST OF A TWO-STORY MASS-TIMBER BUILDING WITH RESILIENT ROCKING WALLS

*Keywords:* Cross laminated timber; NHERI TallWood project; Resilience; Rocking wall; Shake table test.

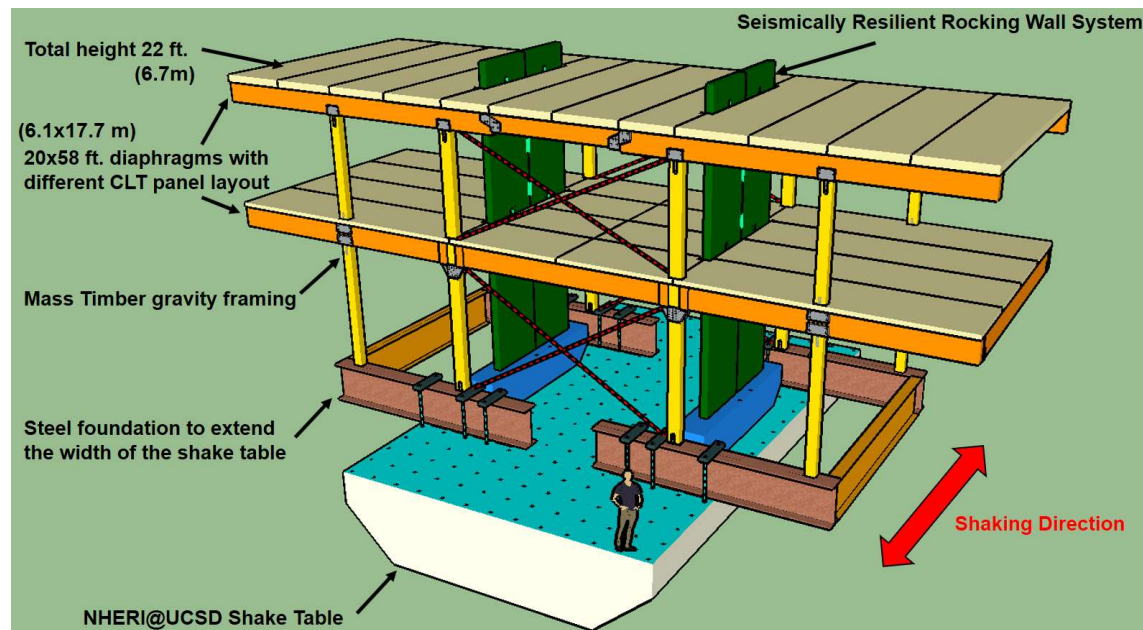
Figure 2. Concept of two-story shake table test specimen (<http://nheritallwood.mines.edu/>).

These considerations led to a 6.7 m (22 ft.) tall test building (3.6 m (12 ft.) at first floor, 3.1 m (10 ft.) at the second floor) with a 17.7 x 6.1 m (58 x 20 ft.) floor plan as shown in Figure 2. The specimen had an open floor plan and relatively high diaphragm aspect ratio in the direction of the shaking. Two different diaphragm designs were implemented, including a wood-only diaphragm at the floor level and a concrete-CLT composite diaphragm design at the roof level (concrete topping not shown here). The diaphragm design was conducted by the Oregon State University collaboration team through the support of Tallwood Design Institute.

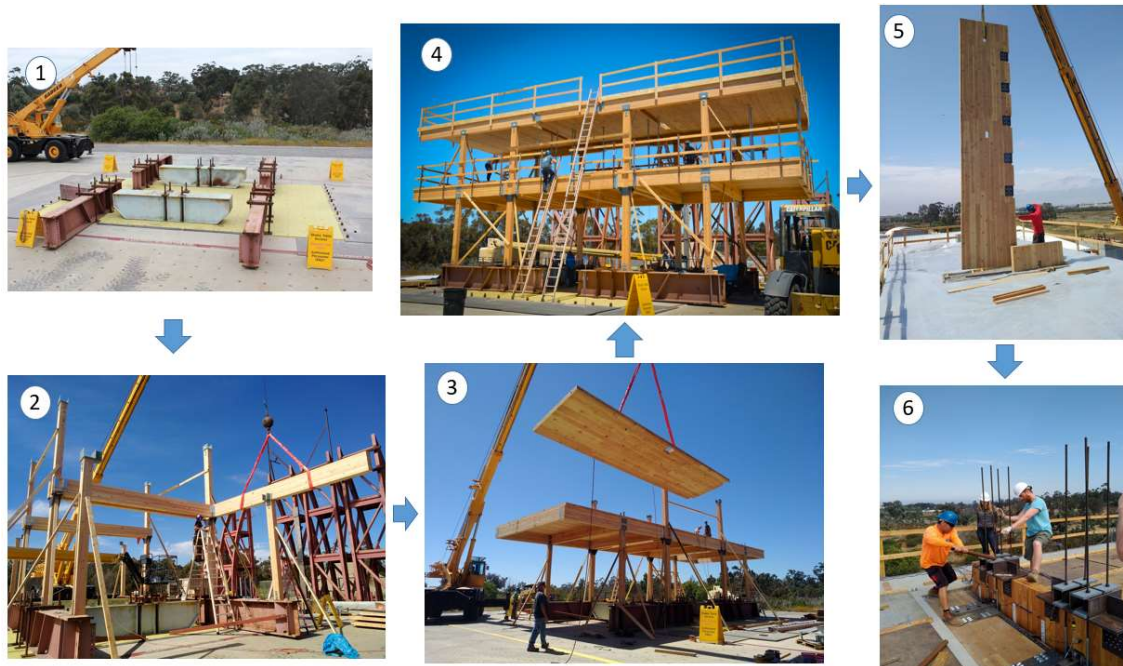
Figure 3. Construction process (1) Foundation preparation (2) Glulam framing (3) CLT panel installation (4) Gravity system completed (5) CLT rocking wall installation (6) Post-tensioning.

The construction of the test building was contracted to Seagate Structures Ltd. America with two carpenters on site during the construction process. The UCSD site crew (two persons) helped to operate the crane. Select photos that highlighted the construction process are illustrated in Figure 3. The shake table foundation was first expanded (Step 1 in Figure 3) to accommodate the building floor plan. The construction of the wood gravity frame (Steps 2 through 4) only took four days to complete. The preparation and pouring of the concrete composite layer for the roof diaphragm was done by a different contractor after the wood frame was completed (not shown in Figure 3). After the concrete had cured, the CLT rocking walls were inserted into the building (Step 5) and connected to the diaphragm and the foundation. During this process, additional steel trench plates were also placed on the floor and the roof in order to bring the total seismic mass to the design level. The last step of construction was the post-tensioning of the rocking wall. Because the needed post-tension force level was relatively low, the post-tensioning was achieved by tightening the nuts manually while monitoring the tension forces using load cells (Step 6). The completed building is shown in Figure 4.

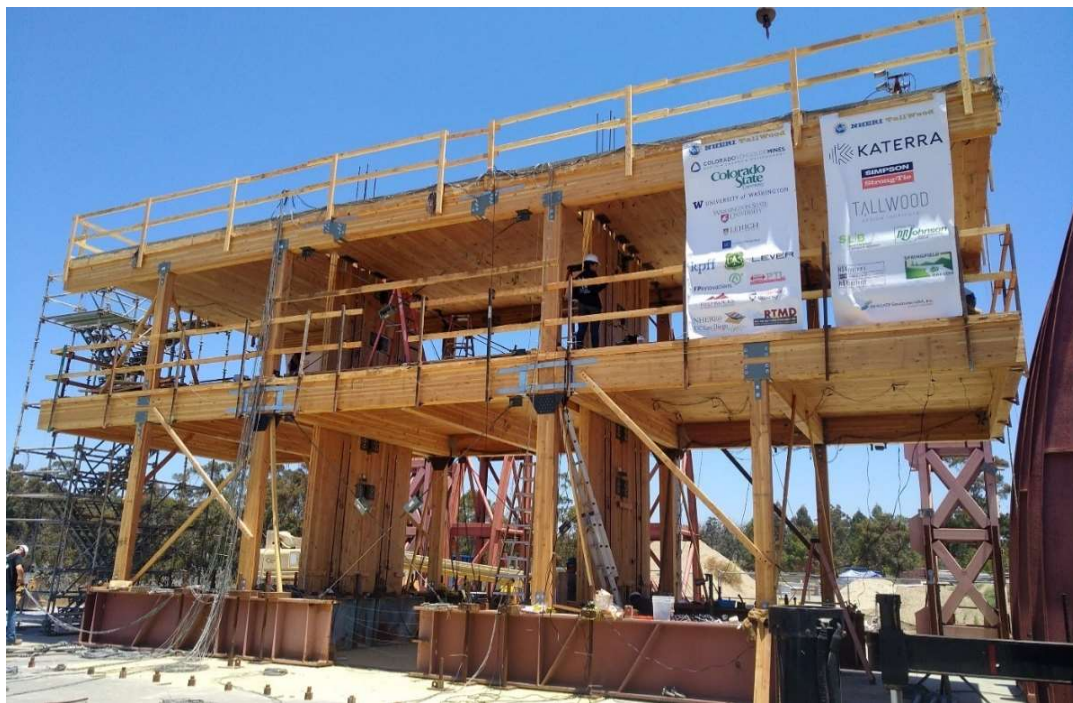
Figure 4. Fully constructed test building on steel foundation connected to the shake table.

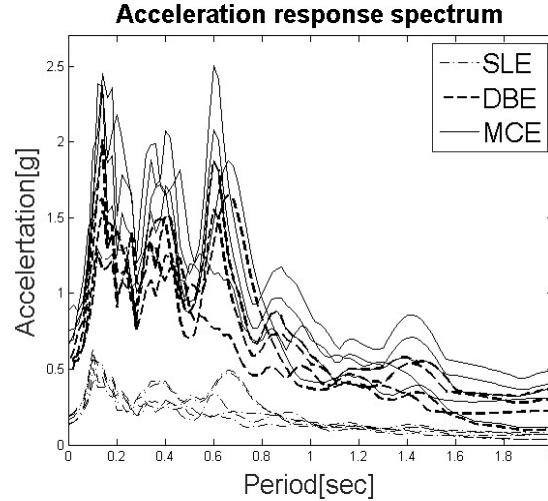
Figure 5. Spectral acceleration of the ground motions used in the test program.

During the test program, the research team hosted two public testing events, in which the original Northridge ground motion record was applied to test building twice in a row. These tests were planned in order to demonstrate the ability of the building to withstand two large earthquakes consecutively without the need for repair. At the final day of testing, after imposing multiple MCE ground motions without observing damage in the building, the researchers increased the scale factor of the ground motion to 120% of the original MCE level (reaching an approximate return period of 3900 years) in order to induce yielding behavior of post-tension rods. The list of ground motions and the intensities used in the test program was presented in Table 2. The spectral acceleration plots of the ground motion inputs (obtained using the measured shake table feedback acceleration) were presented in Figure 5.

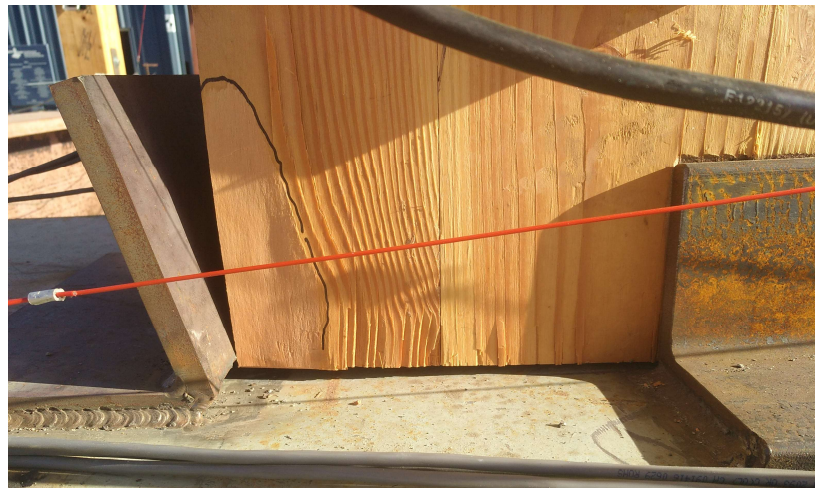
Figure 6. Observed damage to rocking wall corner after MCE level test.

Damage inspection was conducted initially after each test. But when it was discovered that SLE level test did not result in any damage, the inspection was done only for DBE and MCE level tests. There was no visible damage on the gravity frame system and the rocking walls except some cosmetic local chipping and crushing (e.g. rocking wall corner chipping as shown in Figure 6 and marked with black ink). This type of damage did not affect structural performance or stability of the system. There was no damage observed for the CLT diaphragm. There was no damage to the connections between the rocking wall and diaphragm either because the vertical slot detail in the rocking wall (see Figure 7) efficiently transferred the lateral force without limiting the movement of the wall and diaphragm during the movement. Test results validated the resilience design objectives intended for the system.

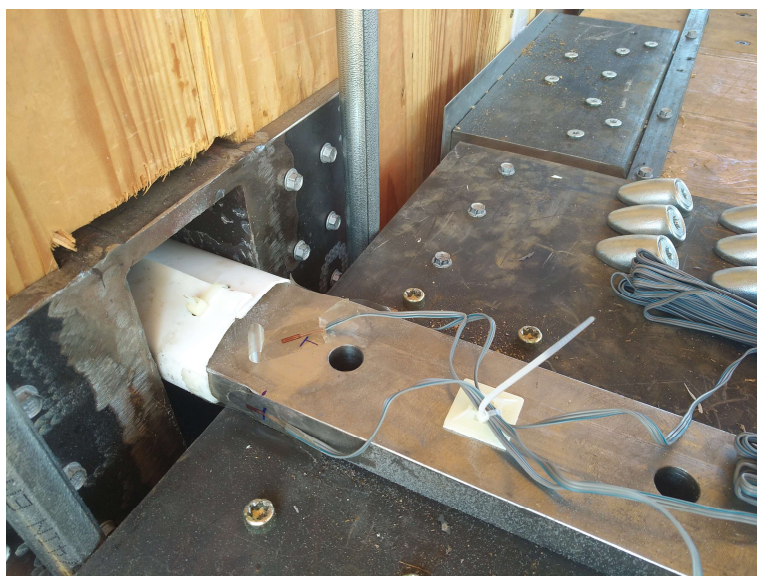
Figure 7. No damage at the wall-diaphragm shear transfer connections.
