# Drinking Water Security Challenges in Rohingya Refugee Camps of Cox's Bazar, Bangladesh

**Abstract:** About a million Rohingyas have fled due to the ethnic cleansing in Myanmar and sought refuge in Bangladesh. The refugees are located in temporary settlements on hilly areas of Cox's Bazar with inadequate water and sanitation facilities, giving rise to diseases such as cholera, typhoid, and diarrhea. This exploratory study reports drinking water security challenges in two Rohingya refugee camps within the larger camp network—Camp 2 and the recently-built Camp 4 Extension (Camp 4Ext)—to discover the key everyday issues refugees are facing related to drinking water. Both qualitative and quantitative methods have been applied to determining whether contamination is occurring during the collection, transportation, and storage of drinking water by comparing the water quality at the source with that in storage. The results show that Camp 4Ext is more suited for living in several respects compared with the other camps, attributable to significantly better planning during its construction: there is a lower prevalence of diseases, lower water collection times, higher standards of sanitati

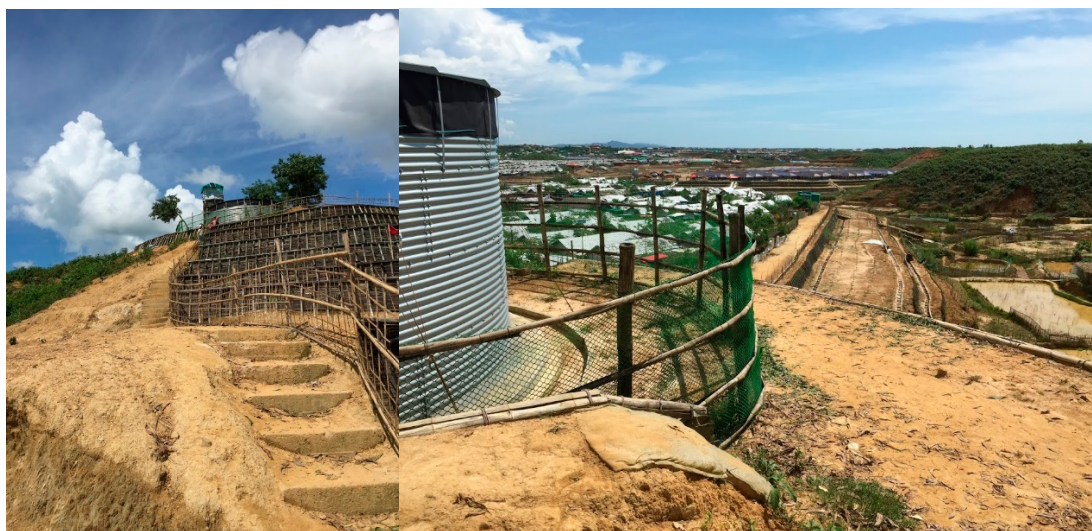
**Figure 2.** Water supply tank in Camp 4Ext, October 2019, Credit: SMN Uddin.

Camps 2E and Camp 2W have 352 and 299 functional water points respectively, with 65 and 63 people per water point respectively [64]. Camp 4Ext has 47 functional water points, with 126 people using per point [64]. The ratio of people to functional water points abides by the standard level. Overall, the most common source of drinking water was tube wells, as reported by 77% of the households combined. This is the main source in Camp 2, with 97% collecting water from tube wells and only 3% from both tube wells and tap stands. The source in Camp 4Ext is a combination of tube wells (30%), tap stand (46.6%), and both tube wells and tap stand (23.3%). Figure 2 shows a water supply tank in Camp 4Ext.
