# A Review of Knowledge-Based Defect Identification via PRPD Patterns in High Voltage Apparatus

**INDEX TERMS** Partial discharge (PD), high voltage motor, power cable, power transformer, GIS, GIL.

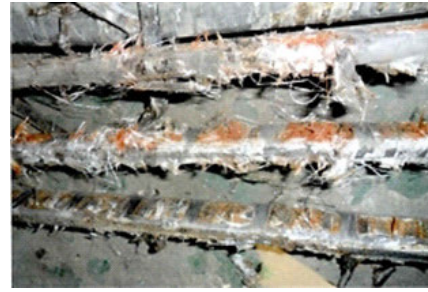
**FIGURE 1.** Stator windings aged for a long time due to internal discharge [5].

PD causes abnormal destructive forces, sometimes resulting in delamination of the inter-turn insulation and the main insulation [4]. Figure 1 shows the stator bars from a 6kV motor after 20 years of service with serious damage observable in the main wall insulation, which is due to internal PDs [5].

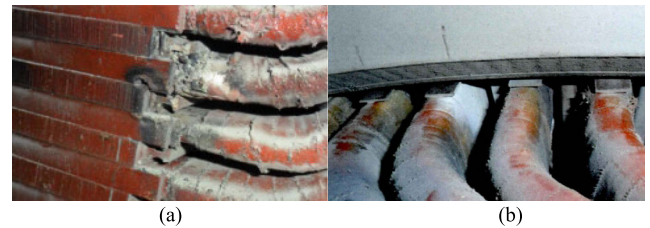
**FIGURE 4.** (a) Corona discharge at the slot outlet causes single phase ground fault on a 10kV three-phase asynchronous motor [18]; (b) Marks of corona discharge at the slot exit of a 2000kW/6kV high voltage motor [5].

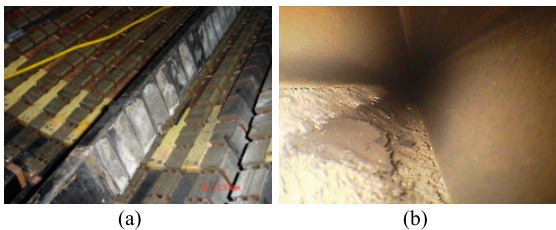
**FIGURE 6.** (a) The fault scene of the spark discharge after the stator bar near the neutral point of the winding is removed, (b) Borescope images of the side of a stator bar surface damaged by vibration sparking [23].
