Long-term behavior of precast, prestressed concrete sandwich panels reinforced with carbon-fiber-reinforced polymer shear grid

Mohamed K. Nafadi, Gregory Lucier, Tugce Sevil Yaman, Harry Gleich, and Sami Rizkalla

PCI Journal (ISSN 0887-9672) V. 66, No. 5, September–October 2021.

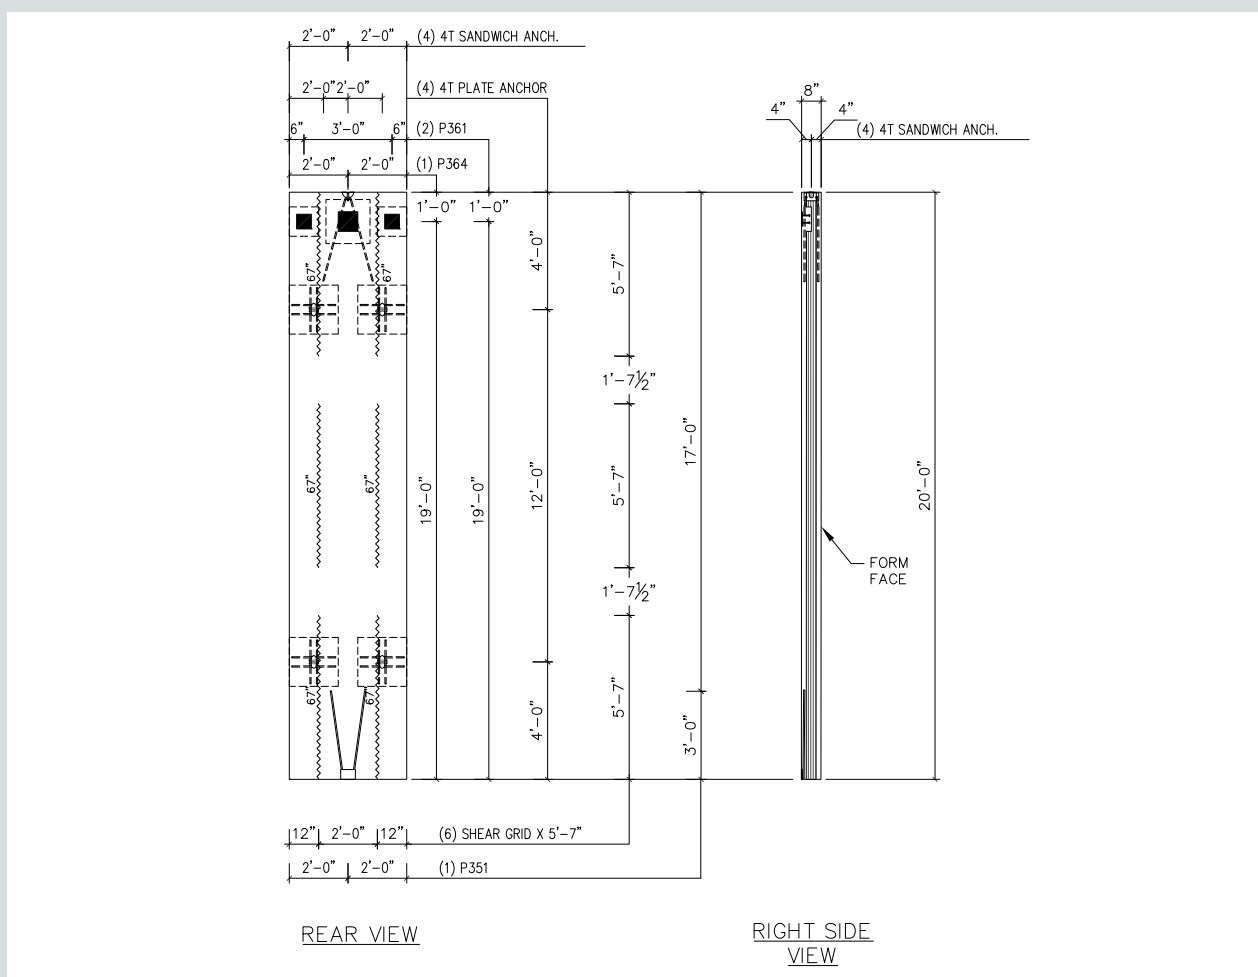
Figure 1. Specimen cross section from producer shop tickets. Note: 1" = 1 in. = 25.4 mm; 1' = 1 ft = 0.305 m.

All panels were identical other than the insulation type. Each panel measured a nominal 8 in. (203.2 mm) thick, 4 ft (1.2 m) wide, and 20 ft (6.1 m) tall. **Figure 1** shows the three layers of the typical cross section of all panels. The panel configuration included the following:

- 2 in. (50.8 mm) prestressed concrete outer wythe
- 4 in. (101.6 mm) center layer of EPS or sandblasted XPS foam insulation
- 2 in. prestressed concrete inner wythe

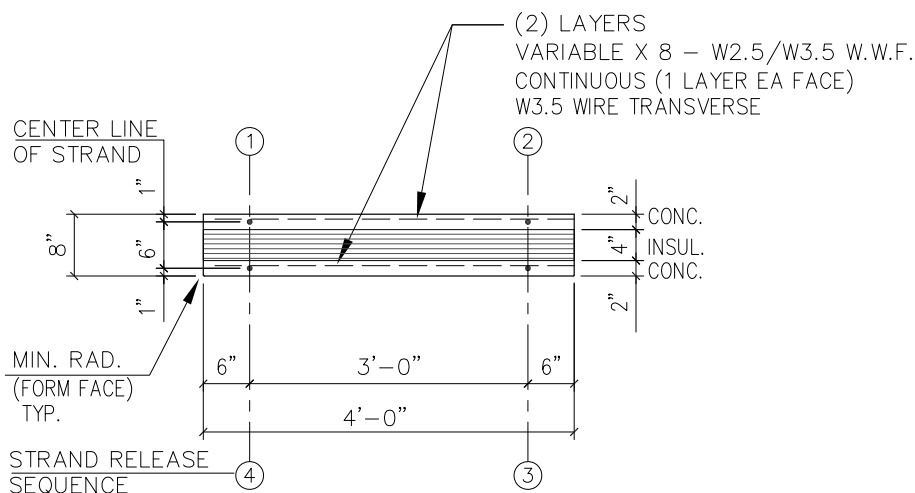
Figure 2. Specimen plan and profile from producer shop tickets. Note: CONC. = concrete; EA = each; INSUL. = insulation; MIN. = minimum; RAD. = radius; TYP. = typical; W.W.F. = welded-wire reinforcement. 1" = 1 in. = 25.4 mm; 1' = 1 ft = 0.305 m.

Each concrete wythe was prestressed longitudinally with two $\frac{3}{8}$ in. (9.525 mm) diameter strands in addition to one layer of welded-wire reinforcement with W3.5 wires spaced at 8 in. (203.2 mm) in the transverse direction. CFRP grid was provided between the wythes to transfer shear across the rigid insulation. Two strips of the grid were placed parallel to the long axis of each panel at the locations shown in **Fig. 2**. A small additional strip of CFRP grid was placed in the transverse panel direction to reinforce the region surrounding the lifting points for a total of 36 ft (11 m) of CFRP grid in each panel. The installed CFRP grids were orthogonal and cut at a 45-degree angle to develop truss action. The rigid foam insulation was thinned in areas surrounding embedded connections and lifting points; however, the insulation was continuous from end to end and from side to side. Care was taken in the experimental design to ensure that the testing setup itself did not artificially enhance the connection between inner and outer wythes.

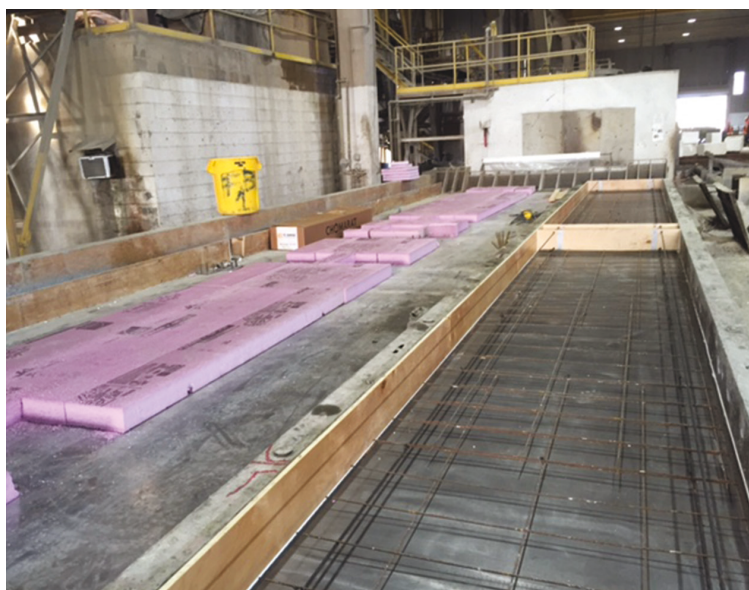
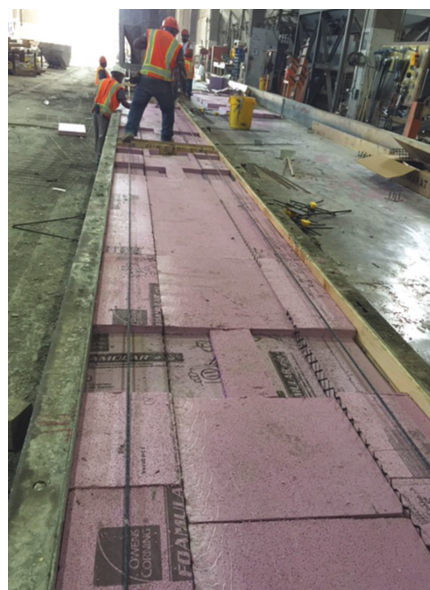
Figure 3. Typical views of panels during fabrication.

Forms with outer wythe reinforcement installed

Foam core with carbon-fiber-reinforced polymer grid installed after casting the outer wythe

The panels were cast flat in long-line production forms. Fabrication began by placing formwork, stressing strands, and laying reinforcement for the outer wythe of concrete. After casting a 2 in. (50.8 mm) layer of concrete for the outer wythe, prefabricated foam insulation and CFRP grid

assemblies were placed on top, and CFRP grid was pushed into the wet concrete wythe beneath. With the CFRP grid projecting up from the insulation, the top wythe welded-wire reinforcement was placed. The top wythe concrete was cast, and embedded plates for connections and lifting devices were set. **Figure 3** shows typical photographs of the panels during construction.

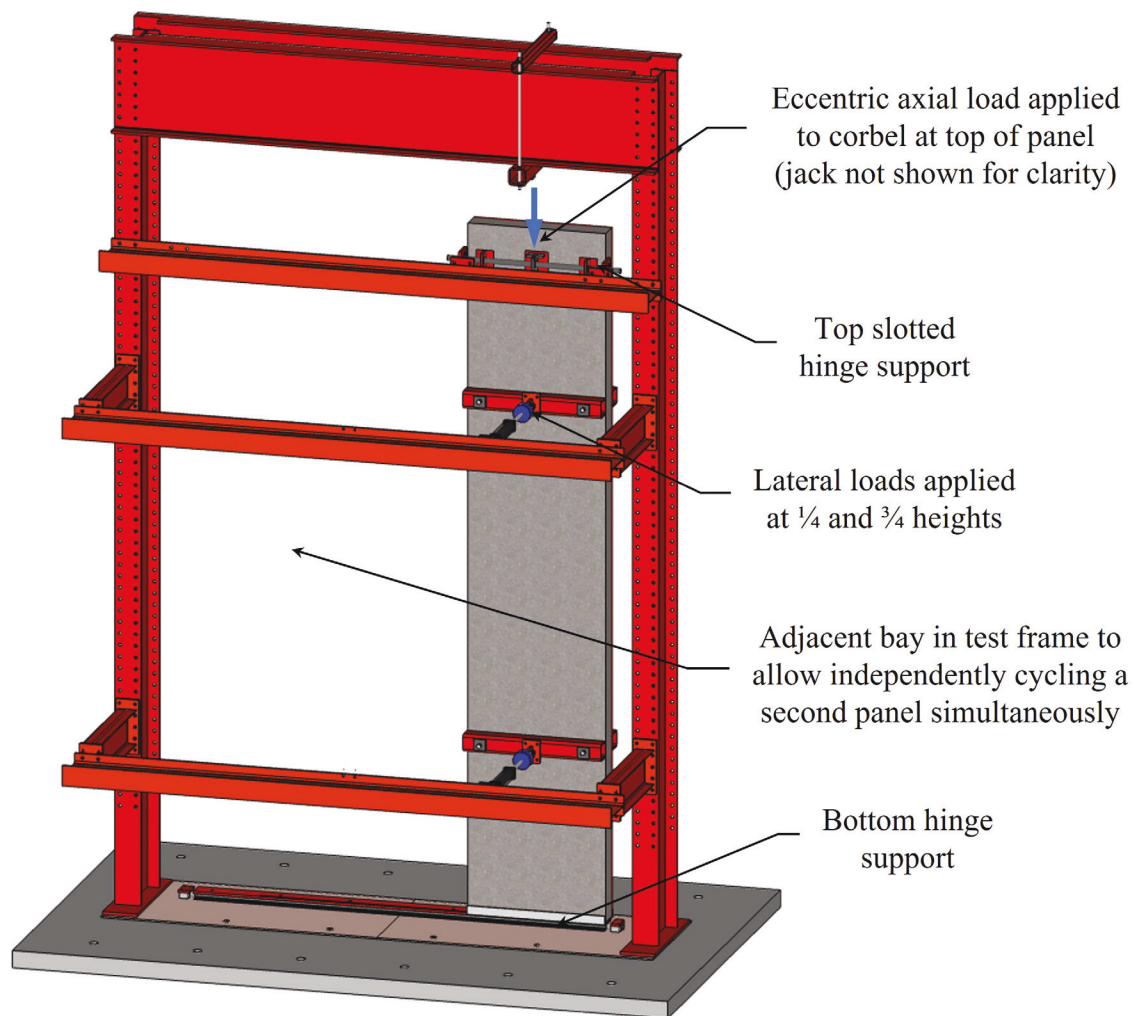
Figure 4. Schematic of the test setup, view of inner wythe.

The test setup was designed to enable cycling two panels simultaneously but independently. Two identical setups were fabricated side by side under the same supporting frame (Fig. 4 and 5). All panels were supported at the bottom on a pin connection that restrained translation in all directions but allowed rotation. Only the inner wythe was connected to the lower connection to avoid artificially enhancing the connection between wythes. All panels were supported at the top on a slotted roller that allowed vertical translation and rotation but prevented

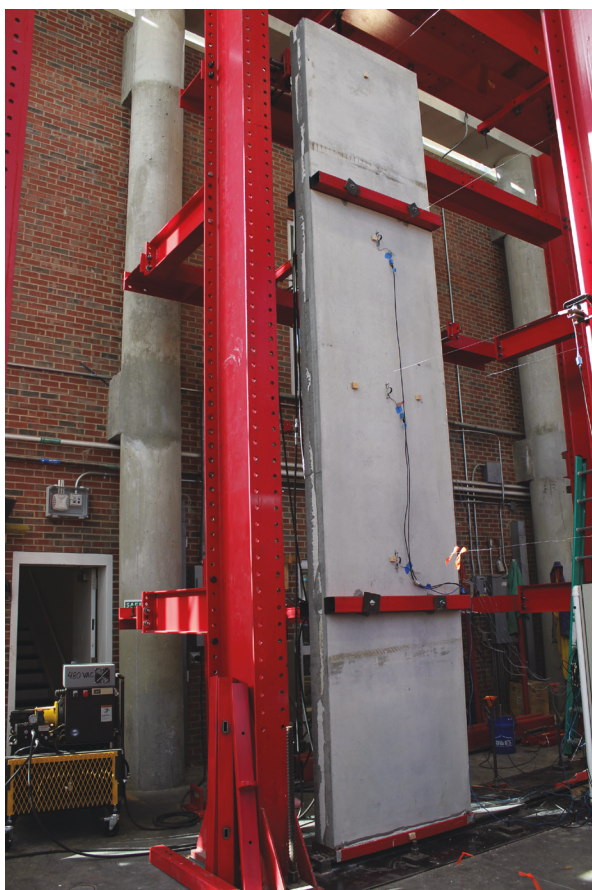
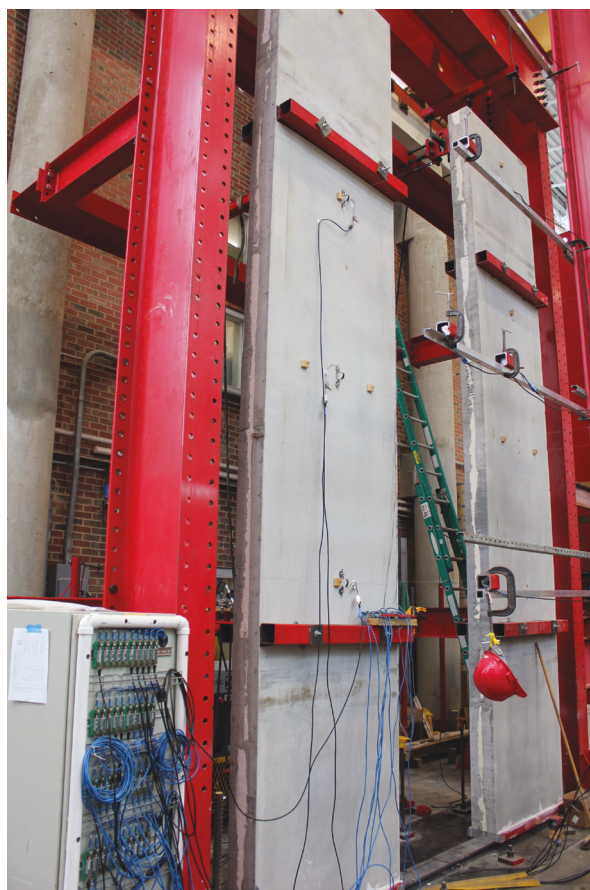
Figure 5. Views of the test setup.

Test setup with one panel

Test setup with two panels

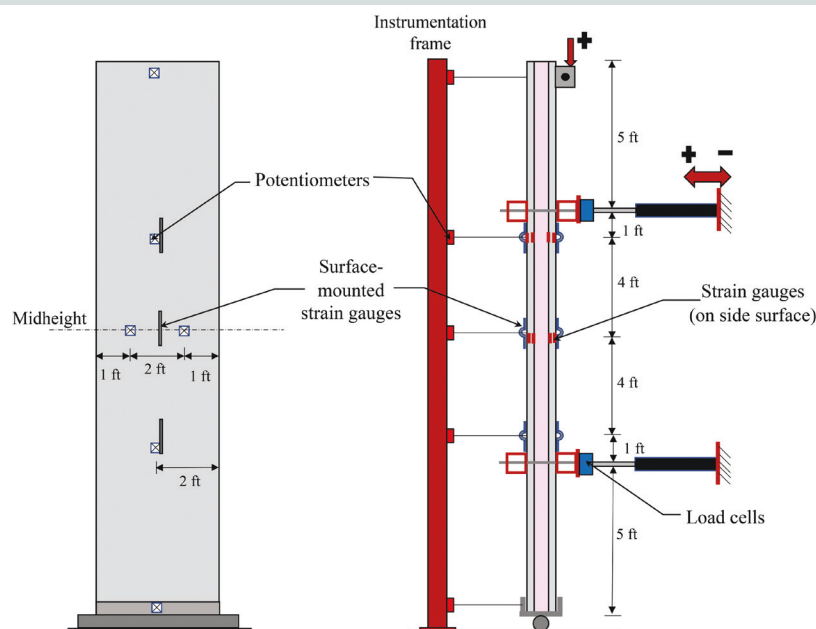
Figure 6. Instrumentation layout and sign convention for applied loads and measured deflections. Note: 1 ft = 0.305 m.

Potentiometers were used to monitor the lateral deflections of the panel throughout each test at different locations (Fig. 6). All deflection data presented in subsequent sections are plotted according to the given sign convention and are adjusted to eliminate the effects of support motion. Lateral deflections were considered positive when they acted to place the inner wythe in compression (that is, positive lateral deflection is the panel moving outward).

This can be attributed to the fact that the upper support was about 1 ft (0.305 m) below the top face of the panel, and the locations of the applied loads were not fully symmetric with respect to the supports (Fig. 6). Hence, the location of the maximum moment was consistently shifted to the lower loading point, whether the load was applied in pulling or pushing directions. All panels were visually uncracked at the start of failure testing, including panels that had been subjected to the 2 million fatigue cycles. The following sections describe the cracking pattern and failure mode for each tested panel.

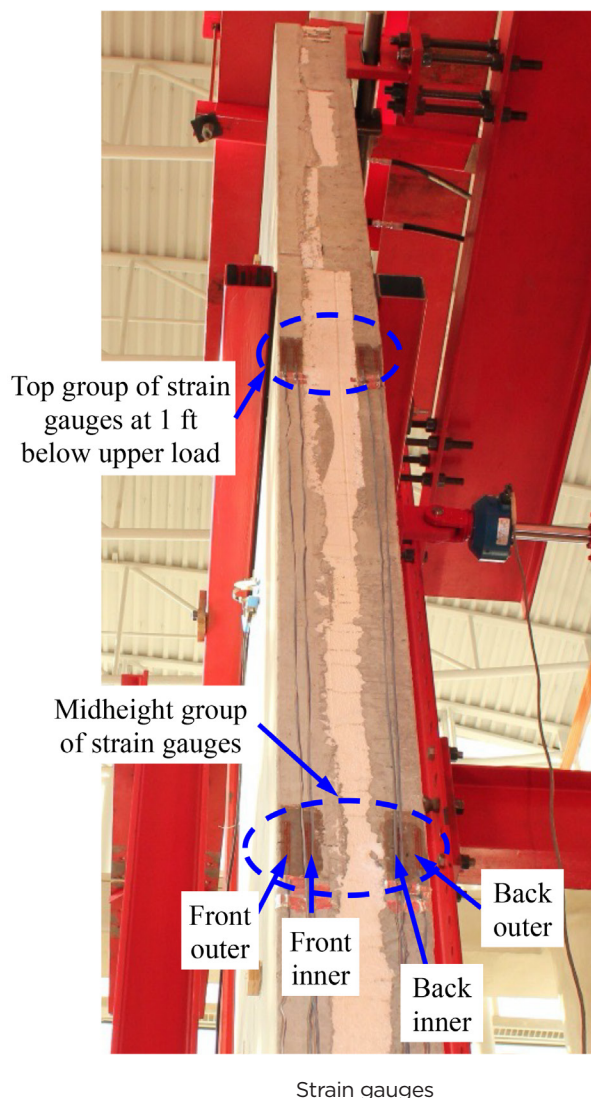
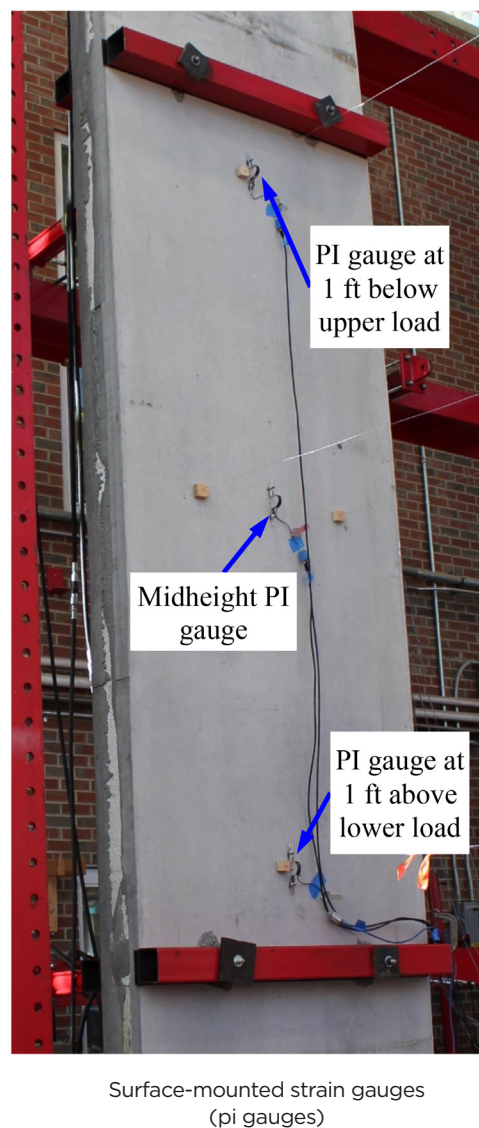
Figure 7. Photographs of instrumentation. Note: 1 ft = 0.305 m.

To characterize the degree of composite action of the panel, two groups of four strain gauges each were attached to the side surfaces of the two concrete wythes. One group of four gauges was attached at midheight, and the other group of four gauges was attached at a location 1 ft (0.305 m) below the three-quarters height (1 ft below the upper load point). All gauges were centered $\frac{7}{16}$ in. (11.1 mm) from the nearest wythe surface or wythe-foam interface. Figure 7 shows the groups of bonded strain gauges.

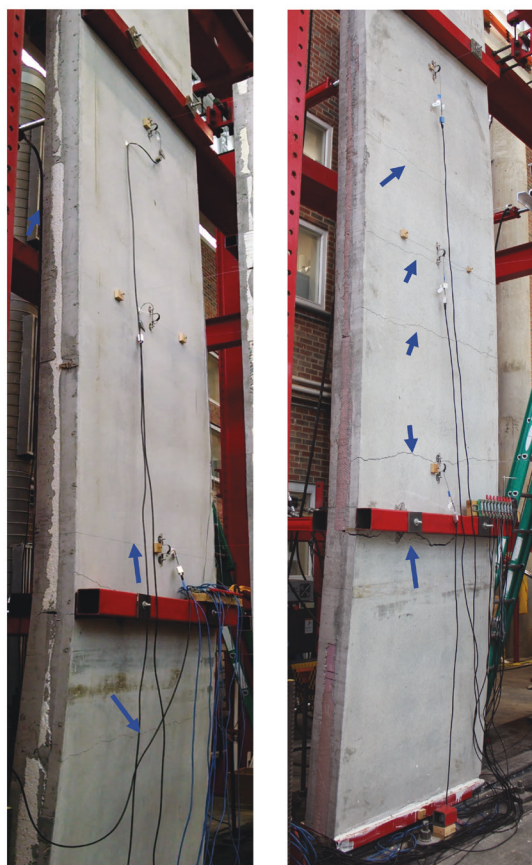
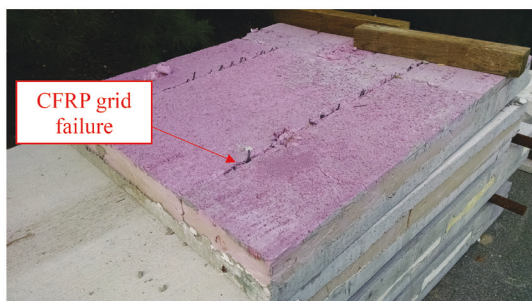
Third test specimen with expanded polystyrene insulation (EPS3)

Third test specimen with sandblasted extruded polystyrene insulation (XPS3)

Typical CFRP grid failure

Figure 8. Cracking pattern and failure mode of test specimens. Note: CFRP = carbon-fiber-reinforced polymer.

Observed cracking in all panels primarily took the form of horizontal flexure cracking in the zone between the load points. **Figure 8** shows examples of typically observed cracks, failure modes, and a typical CFRP grid failure. Critical cracks often developed at or near failure at the lower loading point.

EPS3-fatigued EPS3 behaved in a similar fashion to EPS2, as expected. The panel remained visually uncracked until just before failure. Horizontal cracks developed at the lower load point (Fig. 8). A secondary horizontal crack developed between the lower lateral load point and the support, likely due to a partial loss of composite action at failure. Failure in the shear transfer mechanism then triggered an immediate global flexure and shear failure that took place at the lower

ure and shear crack at the lower load point (Fig. 8). The panel could sustain up to a total applied load of 14,000 lb (62.2 kN) on the pulling segment, followed by a global flexural failure at the lower lateral load point at 13,000 lb (57.8 kN) of total applied load while pushing toward the same 14,000 lb target.

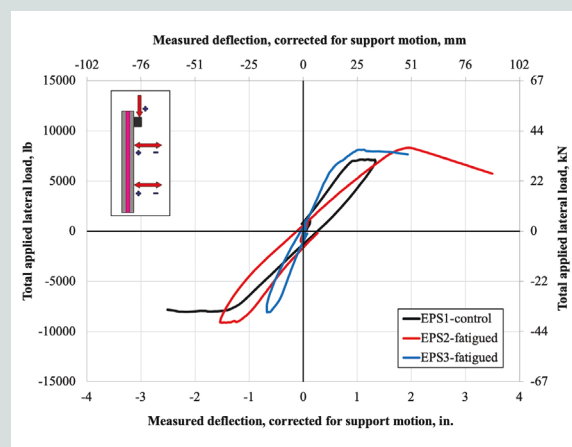
Figure 9. Measured lateral deflections at midheight for the EPS panels. Note: Only the first and last cycles are shown for better clarity. EPS = expanded polystyrene; EPS1-control = first specimen with expanded polystyrene insulation tested to failure; EPS2-fatigued = second specimen with expanded polystyrene insulation subjected to fatigue cycles before the failure test; EPS3-fatigued = third specimen with expanded polystyrene insulation subjected to fatigue cycles before the failure test.

Figures 9 and 10 compare the lateral deflections measured at the midheights of the EPS and XPS panels, respectively. For

better clarity, the figures show only the first and last cycles. The overall performance of all three panels was quite similar. The initial stiffness of control panel EPS1 and fatigued panel EPS2 are quite similar. Interestingly, the initial stiffness of fatigued panel EPS3 slightly exceeds that of EPS1 and EPS2, likely due to random variations in the manufacturing process. In addition, the residual deflections (hysteresis) observed during the static cycles of EPS3 are relatively less than those

from equivalent cycles for EPS1 and EPS2. This finding implies that panel EPS3 had a better bond between concrete and foam than did panels EPS1 and EPS2. It is not reasonable to conclude that fatigue cycling enhanced the EPS3 bond in any way, so it is assumed that this better bond was due to natural variability in the manufacturing process. Panels EPS1, EPS2, and EPS3 were manufactured at the same time from the same material inputs, and no obvious differences in the production of these three panels were observed. Therefore, it is concluded that the fatigue cycles did not influence the final load-deflection behavior of the EPS panels.

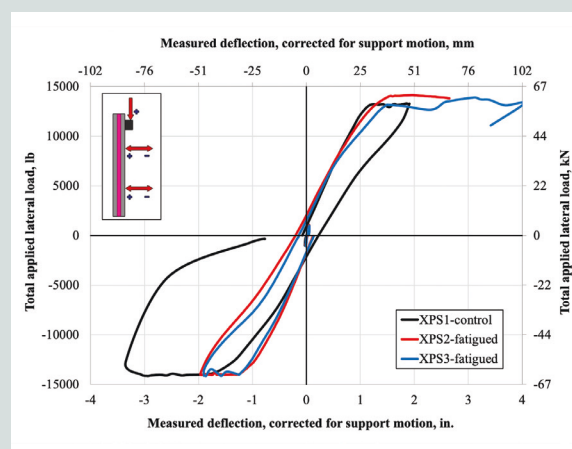
Figure 10. Measured lateral deflections at midheight for the sandblasted XPS panels. Note: Only the first and last cycles are shown for better clarity. XPS = extruded polystyrene; XPS1-control = first specimen with sandblasted XPS insulation tested to failure; XPS2-fatigued = second specimen with sandblasted XPS insulation subjected to fatigue cycles before the failure test; XPS3-fatigued = third specimen with sandblasted XPS insulation subjected to fatigue cycles before the failure test.

Figure 10 shows the measured lateral deflections at the mid-heights of the XPS panels. The behaviors of the control panel XPS1 and the fatigued panels XPS2 and XPS3 could not be distinguished from this plot. The overall behaviors appeared to be identical for all practical purposes, and the initial stiffness matched across the three tests. It is concluded that the fatigue cycles did not affect the final load-deflection behavior of the tested XPS panels.

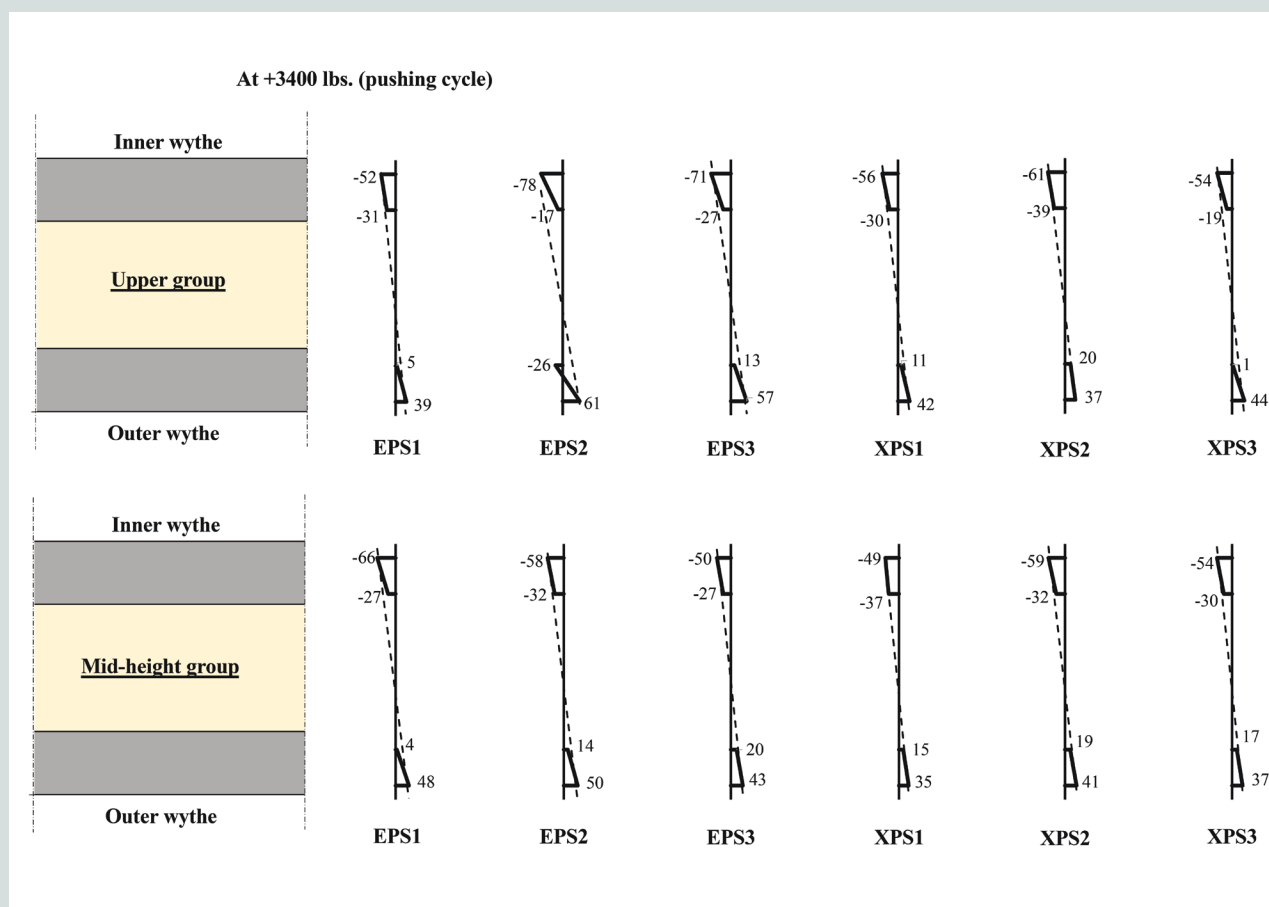
Figure 11. Measured strains across the panel thickness at total applied load of 3400 lb (pushing segment) at upper and mid-height groups of strain gauges. Note: Measured strains are in microstrain. EPS1 = first specimen with expanded polystyrene insulation tested to failure; EPS2 = second specimen with expanded polystyrene insulation subjected to fatigue cycles before the failure test; EPS3 = third specimen with expanded polystyrene insulation subjected to fatigue cycles before the failure test; XPS1 = first specimen with sandblasted extruded polystyrene insulation tested to failure; XPS2 = second specimen with sandblasted extruded polystyrene insulation subjected to fatigue cycles before the failure test; XPS3 = third specimen with sandblasted extruded polystyrene insulation subjected to fatigue cycles before the failure test. 1 lb = 0.00445 kN.

Figure 11 shows strain profiles plotted for each panel at a selected load level, where a total applied lateral load of 3400 lb (15.1 kN) was pushing the panel outward at 1 ft (0.305 m) below the upper load and at midheight of each panel. The load level represents an equivalent uniform pressure on the panel of 42.5 lb/ft² (2.03 kPa), which is the design lateral wind pressure. Despite the small values of the measured strains, which were close to the accuracy of the instrumentation, the recorded strains at the outer and inner surfaces were clearly in opposite directions as the inner wythe was in compression while the outer wythe was in tension. The results indicate

that the strain profiles for all of the panels were nearly linear except one location at the upper gauge group in panel EPS2, where each wythe appeared to act independently. These results suggest that all of the panels were generally able to exhibit a relatively high degree of composite action up to the design load. Furthermore, it could be concluded that the applied fatigue cycling before the failure test had a minimal effect on the composite action between the wythes.

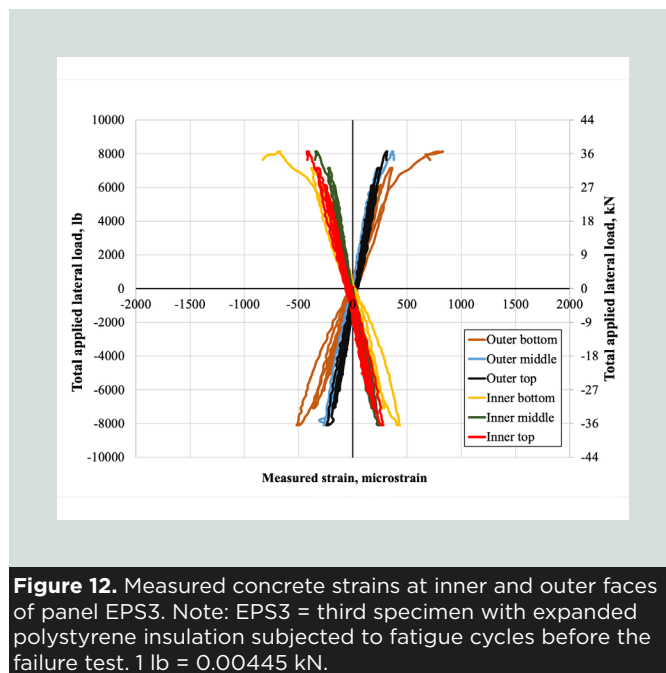
Figure 12. Measured concrete strains at inner and outer faces of panel EPS3. Note: EPS3 = third specimen with expanded polystyrene insulation subjected to fatigue cycles before the failure test. 1 lb = 0.00445 kN.

Figure 12 shows an example of measured strains at both the inner and outer concrete faces for panel EPS3. The measured strains were generally small in value and symmetrical with respect to the vertical axis. The load versus strain behavior was fairly linear up to the failure at all locations except near the lower loading point at both the inner and outer faces, where flexural and shear cracks initiated before failure. This behavior is consistent with the visual observations during the test, which did not reveal any cracks until just before the failure.
