# Impacts of Climate Change Induced Sea Level Rise, Flow Increase and Vegetation Encroachment on Flood Hazard in the Biobío River, Chile

**Citation:** Schoener, G.; Muñoz, E.; Arumí, J.L.; Stone, M.C. Impacts of Climate Change Induced Sea Level Rise, Flow Increase and Vegetation Encroachment on Flood Hazard in the Biobío River, Chile. *Water* **2022**, *14*, 4098. <https://doi.org/10.3390/w14244098>

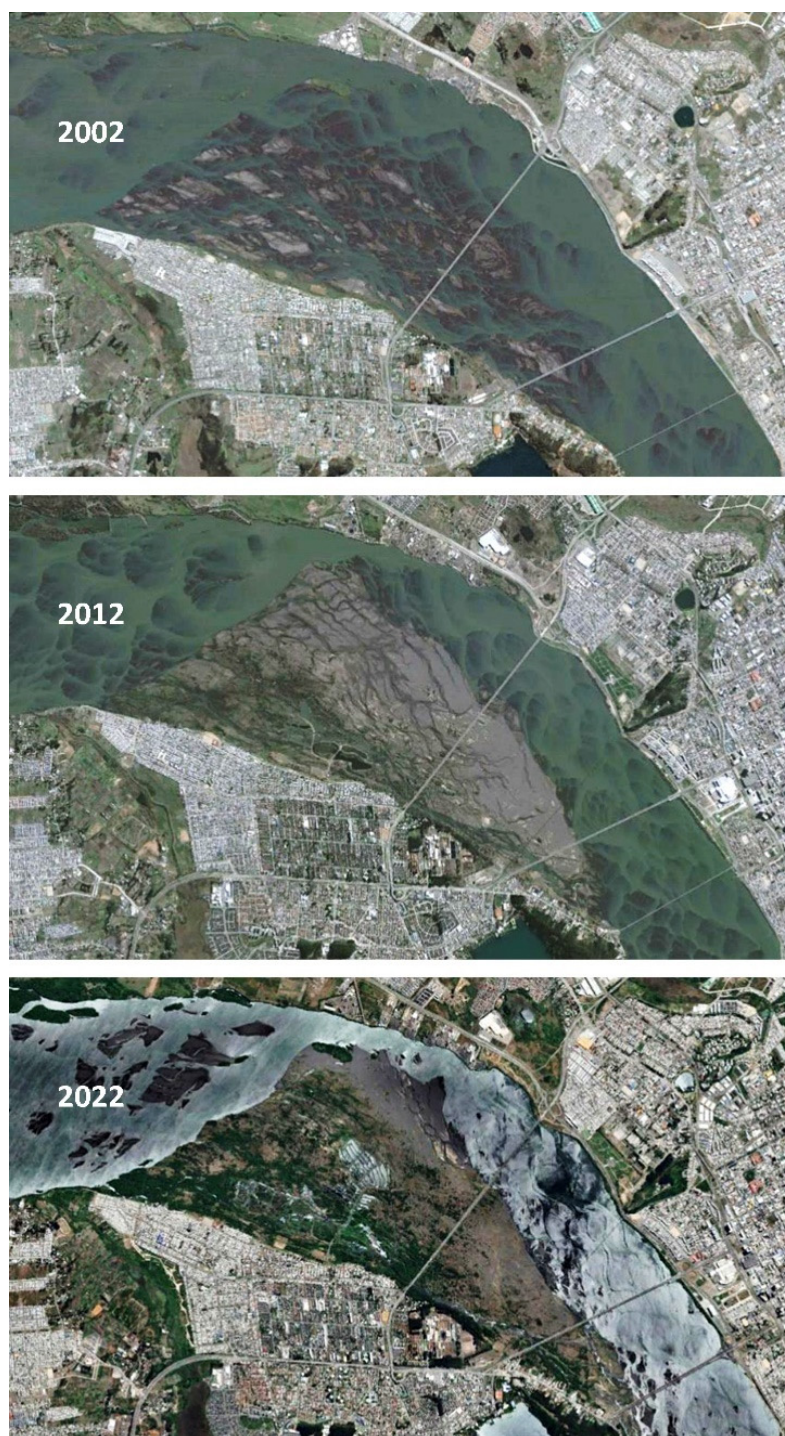
**Figure 4.** Imagery from 2002 (top), 2012 (center) and 2022 (bottom) showing vegetation changes on the sand bar in the lower Rio de la Platte River (image source: Google Earth).

Review of aerial photographs and field investigation conducted by the authors in 2022 reveal that vegetation on a large sand bar present on the south side of the channel has increased substantially over the past 20 years (see Figure 4). Establishment of vegetation—including a dense riparian forest near the south bank that gradually transitions to shrub and scrub vegetation towards the active channel—has likely been promoted by the lack of high flows during the more than decade-long megadrought (see Figure 2).

The drastic increase in vegetation on the sand bar that can be observed for the 20-year period 2002–2022 in the study area (see Figure 4) is likely related to the more than decade-long megadrought Chile has been experiencing [23]. Before the drought, which started in 2010, periodic high flows (see Figure 2) would scour the channel and remove large vegetation. After 2010, annual average peak discharge decreased to less than half of the pre-drought record. Similar patterns can be observed in other Chilean rivers. Pacheco et al. [44]
