EMPTY CONTAINERS, OVERFLOWING RIVERS: STATE FUNDED FENCING AND IMPACTS IN EAGLE PASS, TEXAS

Abstract.—This study uses hydraulic modeling to examine the impacts of two new fence sections at Eagle Pass, Texas: a container fence and a state-funded fence section south, and downstream, of the already modeled federal border fence. We used the model Nays2DFlood to compare fence and non-fence conditions at various recurrence intervals to determine how the fence is affecting flood extents, water depth, and water velocity. Water depth is deeper in the channel and the floodplain and shallower directly at the fence line when compared to non-fence conditions. Water velocity is faster within the channel and the floodplain and slower at the fence line during fence conditions. These impacts have the potential to adjust sediment regimes at this location and downstream of this area, altering water quality and channel morphology. Demographic analysis also show that particularly susceptible populations, including a majority Latino, low income individuals, those under 5, and those 65–74, are present in large numbers at these fence sections and are therefore vulnerable to flooding.

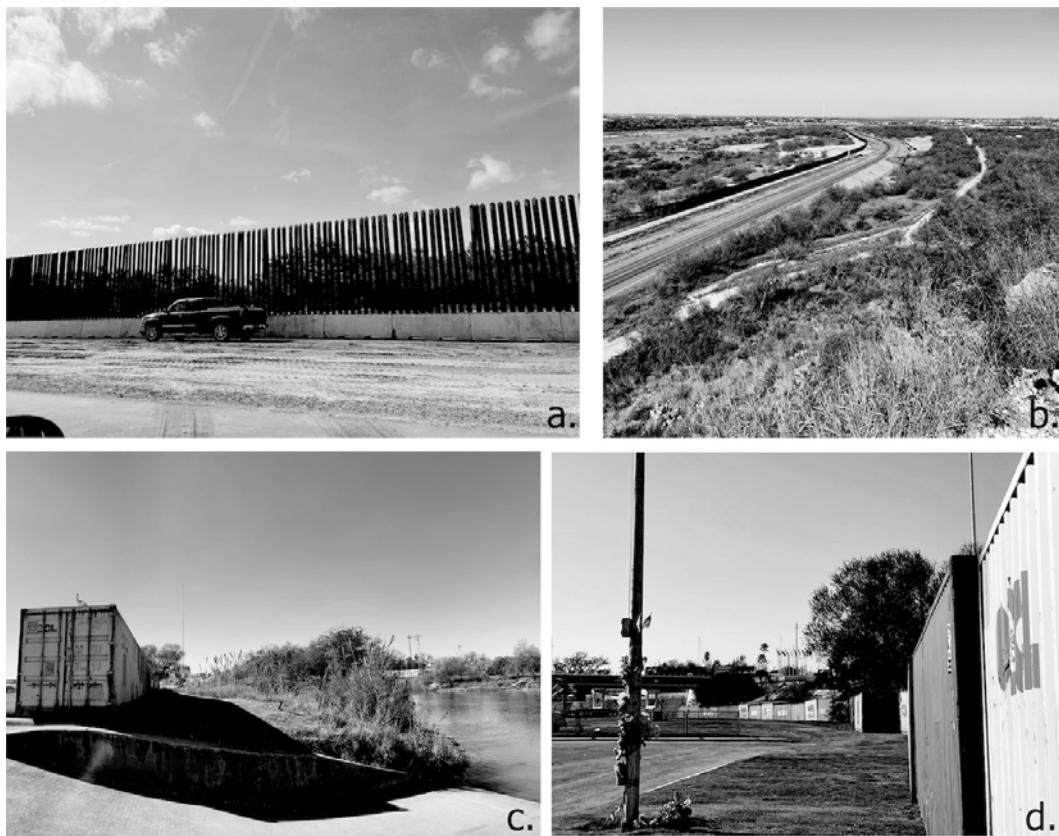
Figure 2. Example of state (a and b) and container fencing (c and d). Note the concertina wire fence by the container fence (c) to the left of the vegetation between the containers and riverbank.

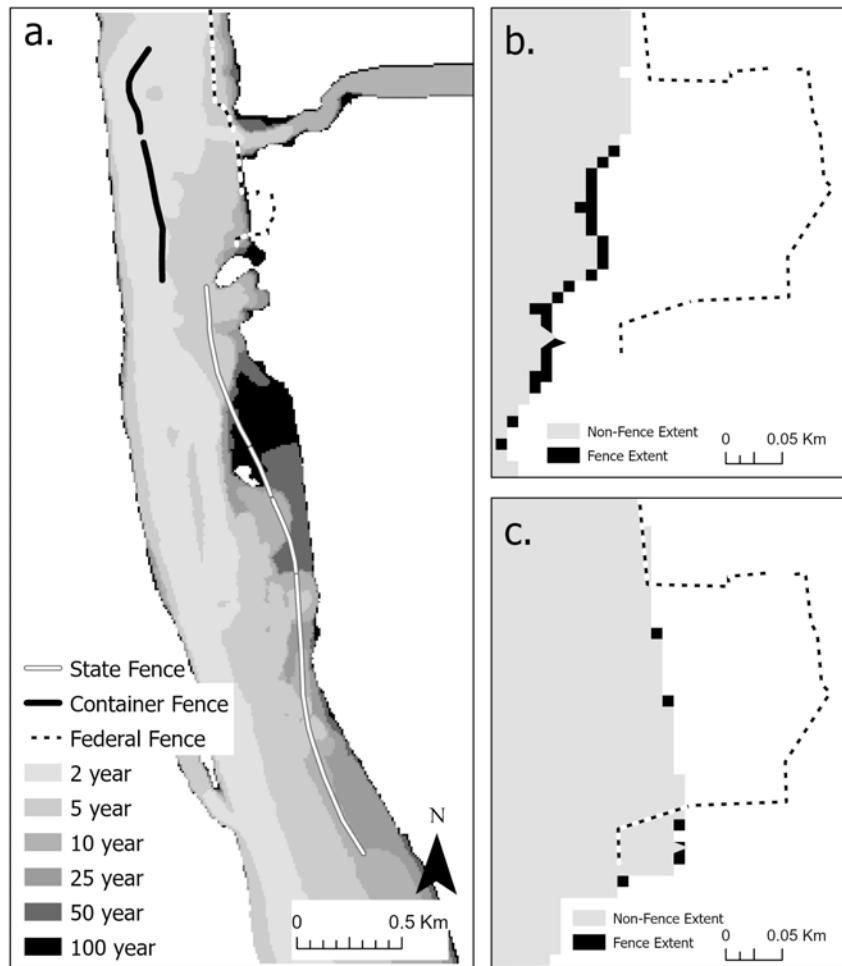
Figure 3. Flood flow extents during fence flows for 2-, 5-, 10-, 25-, 50-, and 100-year flood recurrence intervals. (Fence conditions shown here as the only example because differences in flooding extent between fence and non-fence conditions are not visible at this scale.)

Flood Flow Extent.—At the 2-year recurrence interval, only the container fence close to the river channel interacts with flood flows at this level. The fence condition causes water to go slightly further into the golf course compared to non-fence conditions at the northern portion of the study site near the commercial area (Figure 1 and 3).

During the 5-year flow, both the container fence and the northern 500 m of the state fence interact with this level of flood flow (Figure 3). Compared to non-fence conditions, the presence of the fence shows more flow about 10 m more inland from the channel on both the Mexican and U.S. side appearing in the floodplain. These flows impact the commercial area and golf course on the U.S. side. At the 10-year and 25-year recurrence interval flow, the fence conditions show marginally more flow (~10 m or less) within the golf course and commercial and portions of the state fence section as well as the container fence interact with this level of flow. Similar to the 2-year flow, the 50-year flow also shows the fence holding back some water, but this time near the industrial area near the state fence section and the water does not reach the buildings in the industrial area. And finally, the 100-year flood flow shows no differences in flow between the fence and non-fence conditions.

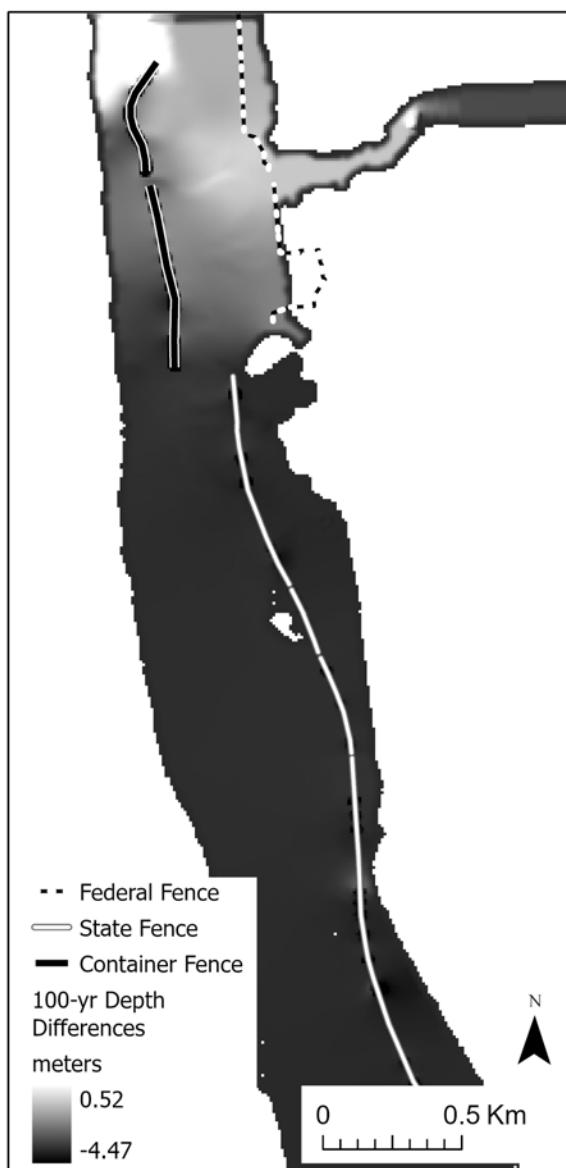
Figure 4. Example of flood depth differences during 100-year flood flow.

commercial area. The northern portion of the state fence continues to show shallower depths at the fence. During the 100-year flow the golf course and softball field are 0.13 m deeper and the gaps between the containers at the canal inlet show deeper flows of approximately 0.04 m during fence conditions compared to non-fence conditions. During the 100-year flow the industrial area comes in contact with flood flows and shows shallower depths of about 0.002 m (Figure 4).

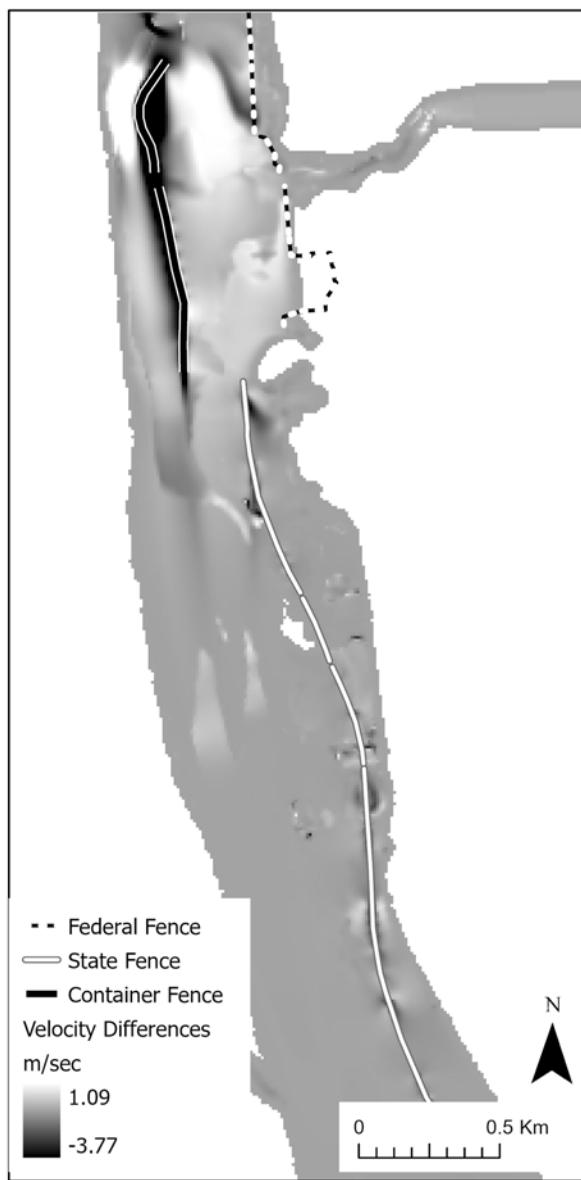
Figure 5. Example of flood velocity differences during 100-year flood flow.

field area (approximately 0.37 m/sec) (Figure 5). The only area that experiences a slower velocity during fence conditions is in the industrial area where it is approximately 0.004 m/sec slower than during non-fence conditions.

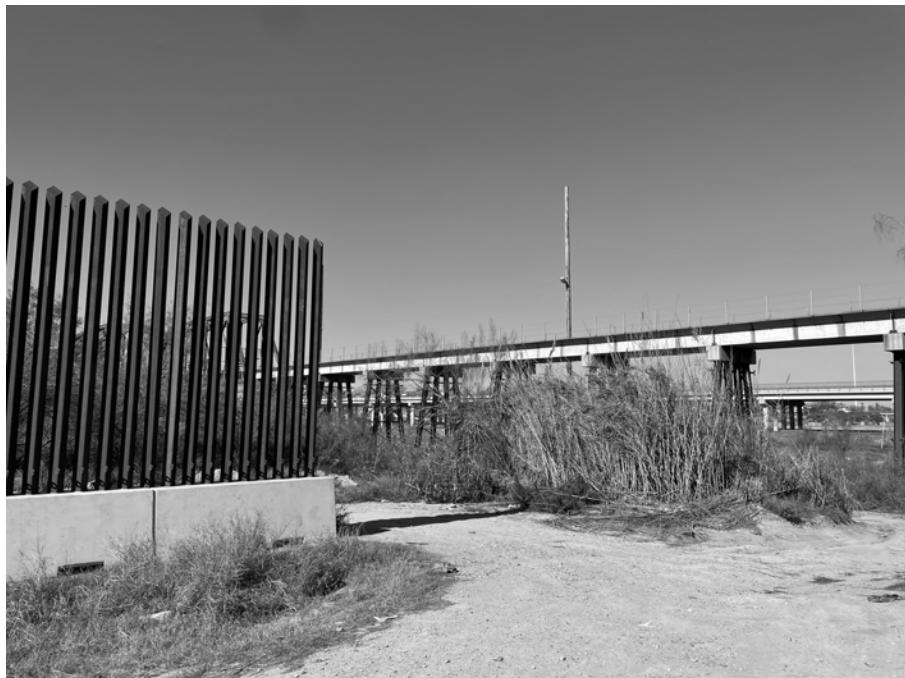
Figure 8. The beginning (northernmost) section of the state fence just downstream of the railroad bridge, International Bridge #2 (in distant background) and the Customs and Border Patrol station.

A second location where rerouting is occurring is immediately upstream of the state fence section (Figure 8) where water is forced to either side of the fence as it encounters this barrier. This portion of the fence is very close to the railroad bridge and the Customs and Border Protection (CBP) building that oversees passage on International Bridge #2 (Camino Real). Previous work on the federal fence's impact of water flow pointed to the CBP building as being in a particularly susceptible area given changes in flow depth and velocity that causes a large pool of water to back up along the fence and towards the CBP station. The new state fence section modeling shows that water velocity will increase just downstream of the CBP station further causing damage to the bridge, the station, and any other infrastructure in the area.
