Jensen EK, Moore JR, Geimer PR and Finnegan R (2024), Combined ambient vibration and surface displacement measurements for improved progressive failure monitoring at a toppling rock slab in Utah, USA.
Front. Earth Sci. 12:1364653.
doi: 10.3389/feart.2024.1364653

Combined ambient vibration and surface displacement measurements for improved progressive failure monitoring at a toppling rock slab in Utah, USA

Erin K. Jensen^{1*}, Jeffrey R. Moore¹, Paul R. Geimer^{1,2} and Riley Finnegan¹

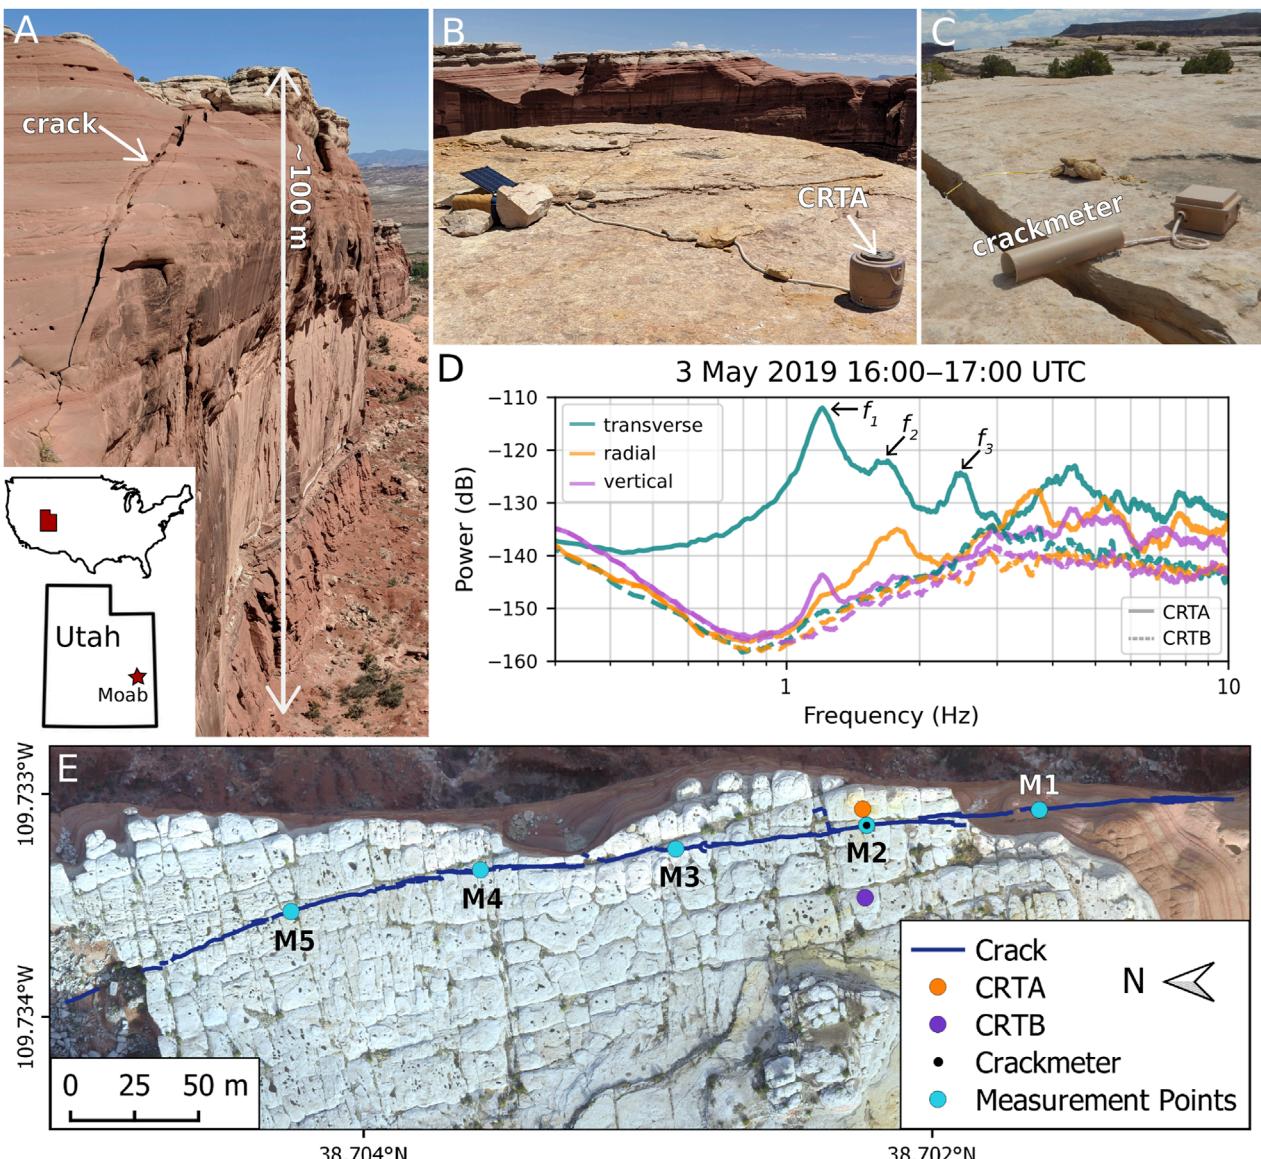
FIGURE 1
 Overview of the Courthouse Mesa rock slope instability near Moab, Utah, USA. (A) View of the south end of the instability where the crack is exposed in Entrada Sandstone. Photos showing (B) broadband seismometer station CRTA on the instability, and (C) the vibrating wire extensometer used to measure crack aperture. (D) Power spectral density plots from CRTA and reference station CRTB from 3 May 2019 showing the first three resonance frequencies (f_1 , f_2 , and f_3) of the instability. Decibel powers are relative to $1 \text{ m}^2 \text{ s}^{-4} \text{ Hz}^{-1}$. (E) Drone-based orthophoto showing the mapped crack trace (blue line) and locations of CRTA (orange circle), CRTB (purple circle), crackmeter (small black circle), and measurement points M1–M5 (blue circles). The crackmeter is co-located with M2.

The Courthouse Mesa rock slope instability is located 25 km north of Moab, Utah (Figure 1A), and is characterized by flexural toppling of a continuous slab from the propagation of a single rear fracture with resultant compressional toe failure (Bessette-Kirton et al., 2022). The slab is delineated by a 500-m-long crack that runs approximately north-south across the ~100-m-high sandstone mesa, ranging in aperture from ~400 mm at the southernmost

We instrumented the instability at Courthouse Mesa with a three-component Trillium Compact 20 s seismometer (station code CRTA; Figures 1B,E) coupled with a 24-bit Centaur data logger, and a Durham Geo Slope Indicator (DGSI) vibrating wire extensometer (crackmeter; Figures 1C,E). CRTA collected continuous ambient vibration data at a sampling rate of 100 Hz for 3 years between 12 October 2018 and 11 October 2021. Data are available in Moore (2013). Crack aperture data were sampled at 30-min intervals for 4 years between 28 May 2018 and 27 May 2022. Data are available in Jensen et al. (2023). Here, we focus on the 3-year period when both instruments were operational but include the full crackmeter record for completeness. The crackmeter had a measurement range of 100 mm and was set with an initial opening of 15 mm. Initial crack aperture on 28 May 2018 was 250 mm. Both instruments were installed ~180 m from the south end of the crack in a safe and easily accessible area (Figure 1E). CRTA collected nearly continuous data, with only minor interruptions due to intermittent power losses during winter and damage sustained by a storm in June 2020. The longest period with inconsistent data coverage occurred between 31 December 2019 and 27 January 2020, when prolonged cloudy conditions caused power losses resulting in 286 h of missing data. Otherwise, data gaps were minimal and occurred only briefly on 20 January 2019 (23 h of missing data), 6–7 June 2020 (40 h of missing data), and between 3 and 4 January 2021 (25 h of missing data). Crack aperture data had no gaps during the monitoring period. Between October 2018 and May 2019, we deployed a second three-component Trillium Compact 20 s seismometer (station code CRTB) on the stable, west side of the crack (~40 m away from CRTA) as a local reference (Figure 1E). CRTB also suffered from intermittent data gaps due to power losses during the winter of 2018–2019. In addition to continuous surface displacement data from the crackmeter (co-located with M2), we conducted 15 repeated crack width measurements over the 4-year monitoring period at five locations along the crack (labeled M1–M5) using a tape measure (± 2 mm precision) to assess differences in the magnitude of crack aperture changes across the site (Figure 1E).

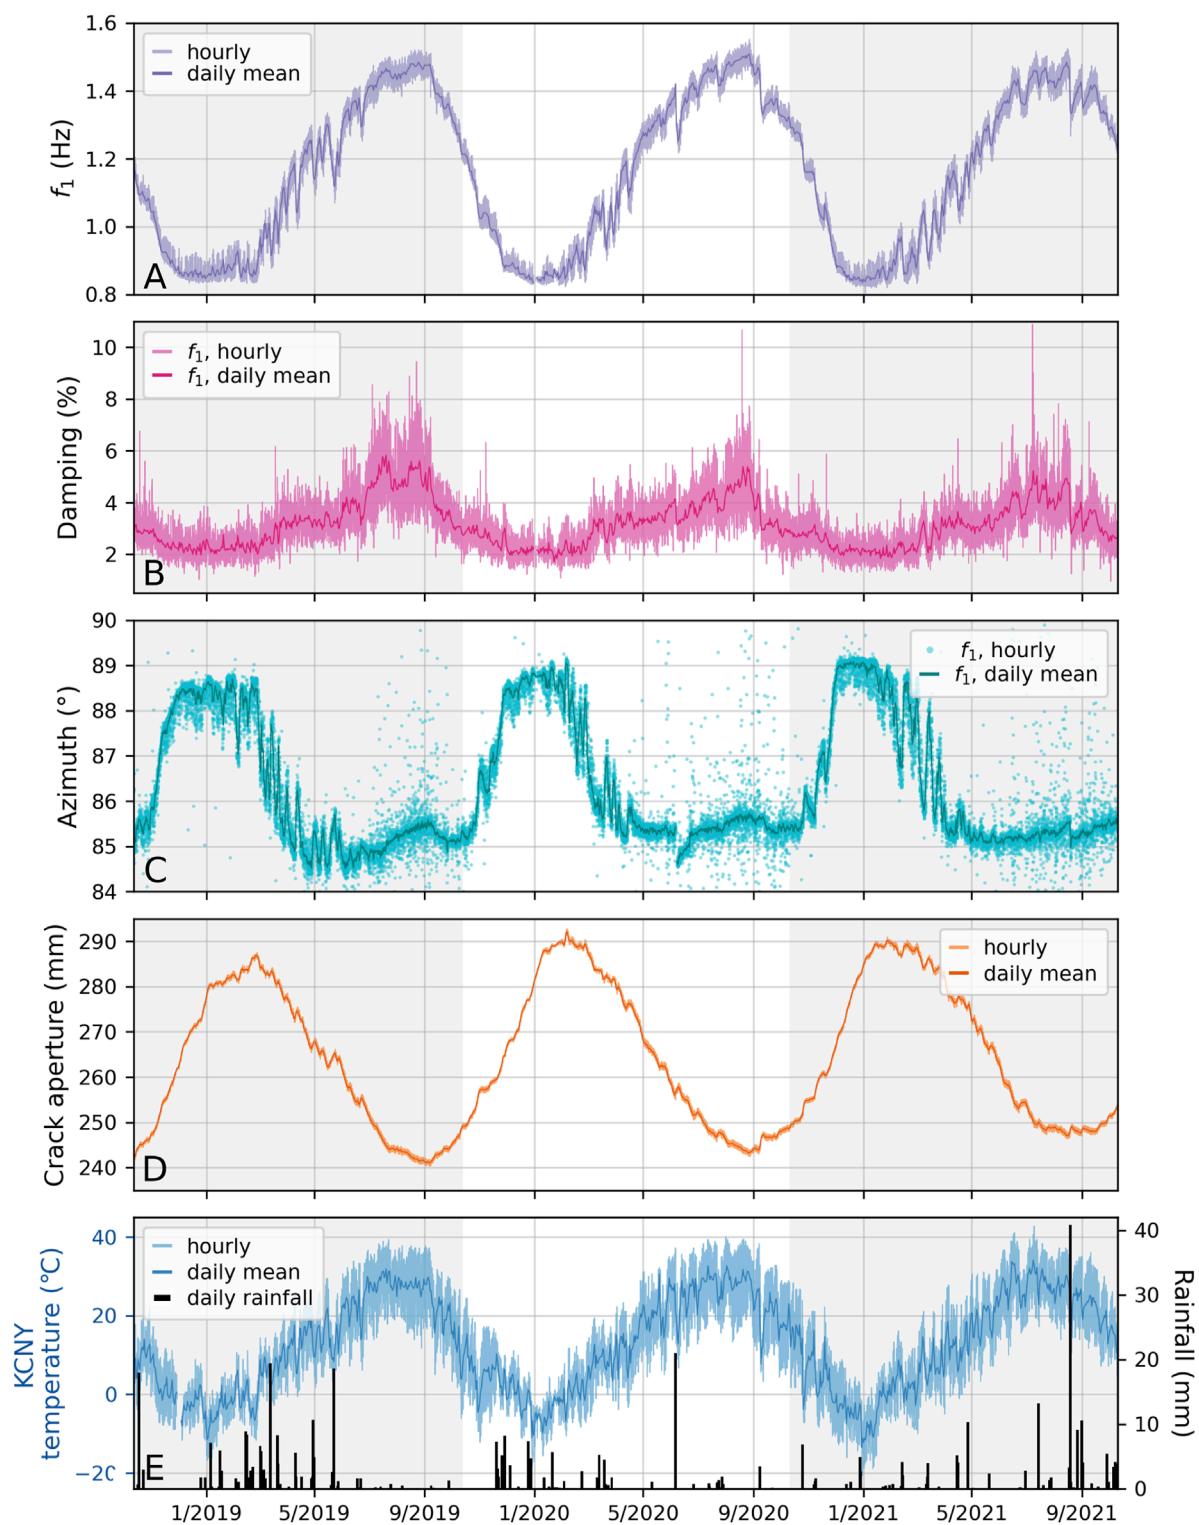
FIGURE 2

Monitoring data from the Courthouse Mesa rock slope instability between October 2018 and October 2021. **(A)** Time series of the first resonance frequency (f_1) showing hourly measurements in light purple and daily mean frequency in dark purple. **(B)** Hourly (light pink) and daily mean (dark pink) damping values for f_1 . **(C)** Polarization azimuth of f_1 (relative to magnetic north) showing hourly (light blue) and daily mean (dark blue) measurements. **(D)** Hourly (light orange) and daily mean (dark orange) crack aperture measured by the crackmeter (Figures 1C,E). **(E)** Hourly (light blue) and daily mean (dark blue) air temperatures recorded at weather station KCNY (located 5 km north of Courthouse Mesa). Daily precipitation recorded at KCNY is shown with black bars. Gray shading highlights yearly intervals of monitoring.

We tracked damping and polarization attributes for f_1 throughout the monitoring period. Damping varied between 2% and 8%, with no apparent long-term changes (Figure 2B; Figure 3B). In general, damping was highest during the summer and lowest during the winter. Polarization analysis indicated that modal deflection at f_1 is highly polarized (Figure 2C; Figure 3C). The degree of polarization was near unity during winter and spring, with slightly more scatter during summer and fall (0.98–1; Supplementary Figure S3). We observed annual variations in f_1 azimuth of about $\pm 2.5^\circ$ (84° – 89° with respect to magnetic north; Figure 2C), with changes in incidence of $\pm 1^\circ$ (87° – 89° ;

Crack aperture data from the crackmeter (at location M2) showed ~ 50 mm of seasonal displacement with crack aperture ranging from 234 to 247 mm in summer (crack is most closed) to 287–293 mm in winter (crack is most open; Figure 2D; Figure 3D). Daily crackmeter amplitudes ranged from 0.2 to 2.8 mm. As shown in Figure 3D, minimum crack aperture increased by 2–7 mm/year between consecutive summers, with the largest annual increase in opening of ~ 7 mm between 2018 and 2019 (beginning prior to the initiation of resonance frequency monitoring) and smaller changes of 2 and 4 mm in the following years. In contrast, wintertime maximum crack apertures did not follow the same trend, with a ~ 5 mm increase between 2019 and 2020 but less noticeable changes during the following years. Periodic measurements at monitoring points M1–M5 revealed differences in the amplitude of crack opening between the south end of the instability where the crack is widest (M1; Figure 1A) and the north end of the instability where the crack is narrowest (M5). These measurements were taken on 15 discrete dates and thus, do not necessarily capture the absolute minimum and maximum crack apertures during the monitoring period. Differences between summer aperture minima and winter aperture maxima (which reflect a minimum possible annual crack aperture amplitude) revealed 58 mm of opening at M1 with only 11 mm at M5 (Supplementary Figure S4). Measurements at M2 showed 43 mm of seasonal opening, which is consistent with, although slightly less than continuous data from the crackmeter due to the constraints of intermittent measurements.

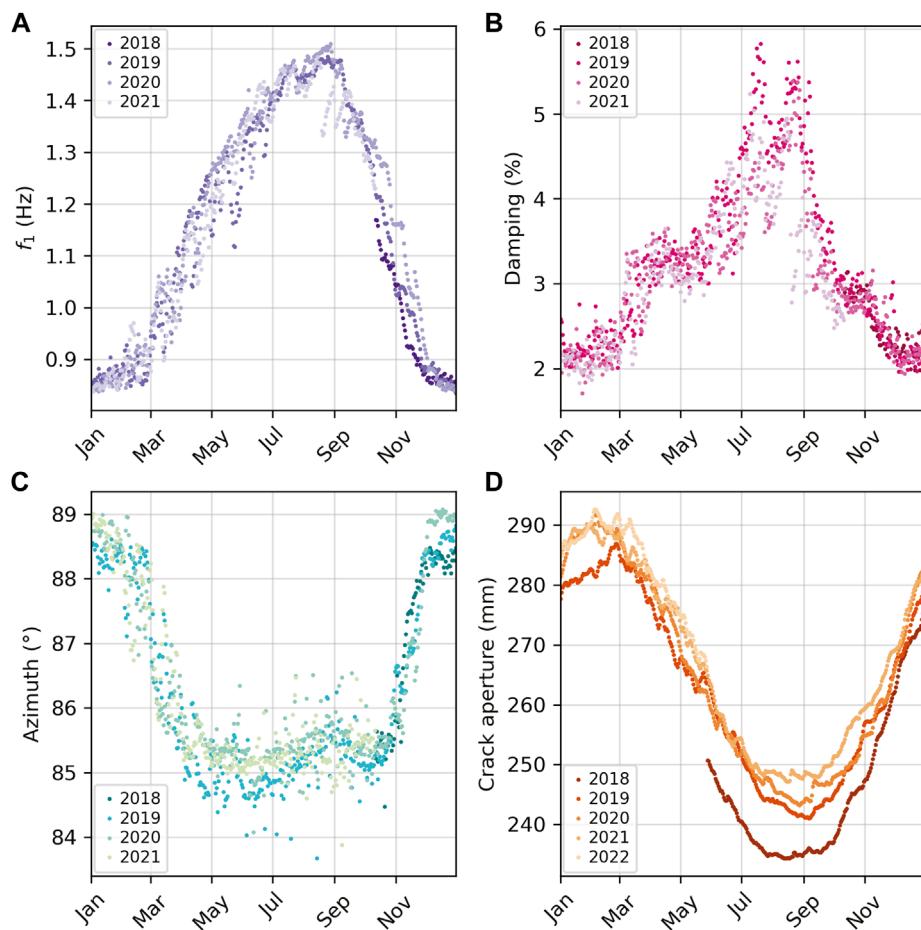
FIGURE 3

Yearly variability of daily mean (A) first resonance frequency (f_1), (B) damping for f_1 , (C) polarization azimuth of f_1 , and (D) crack aperture. f_1 , damping, and azimuth data span the 3-year period between October 2018 and October 2021. The full 4 years of crackmeter data (May 2018–May 2022) are shown.

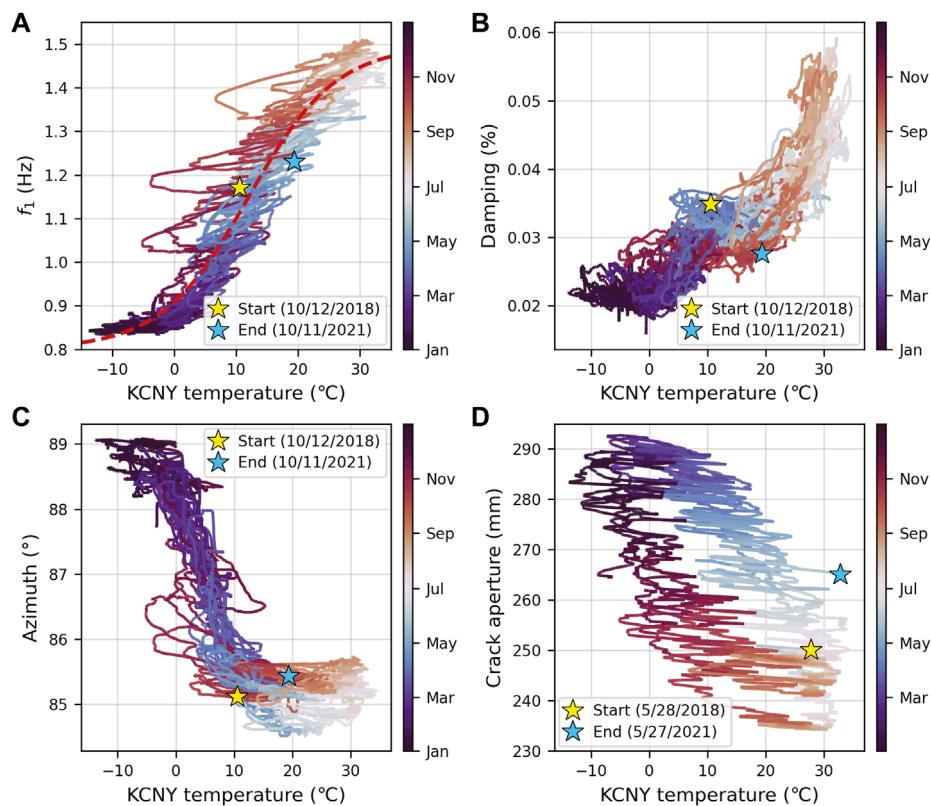
FIGURE 4
Air temperature from weather station KCNY compared with (A) first resonance frequency (f_1), (B) damping for f_1 , (C) polarization azimuth of f_1 , and (D) crack aperture. The sigmoid curve for f_1 as a function of temperature is shown in red (A). The full 4 years of crackmeter data (May 2018–May 2022) are shown.

Frequency changes strongly correlate with air temperature (Figure 4A). Although the overall correlation between daily average first resonance frequency and daily average air temperature showed a clear positive correlation ($R^2 = 0.92$), we observed variable temperature-driven frequency behavior seasonally. During spring and fall, frequency tracked closely with temperature, as shown by the consistent positive slope of the temperature-frequency curve. However, the daily and multi-day temperature sensitivities varied. During the spring, frequency closely followed intermittent, multi-day temperature changes (many of which were associated with rainfall), whereas, in the fall, frequency did not consistently follow short-term temperature changes. This pattern is expressed by seasonal differences in scatter from the annual temperature-frequency regression (Figure 4A). During winter, frequency was also notably less-sensitive to temperature, as demonstrated by the flattening of the frequency-temperature curve when temperatures were below $\sim 0^\circ\text{C}$. We used a sigmoid curve (Figure 4A) to subtract the predicted temperature-dependent frequency trend from measured values. The resulting residuals (as a fraction of measured

As with frequency, we found that damping was generally positively correlated with air temperature, although the relationship varied seasonally and was flat or slightly inverted at times (Figure 4B). Examination of daily temperature-damping relations showed generally poor correlations ($R^2 < 0.2$) during most of the year, with moderately strong positive linear relationships (maximum R^2 values of 0.8) during the months of July through September (Supplementary Figure S6). The relationship between damping and crack aperture shows that damping was highest when crack aperture was smallest (during late summer and fall) and lowest when crack aperture was largest (Supplementary Figure S9).

Annually, azimuth was inversely correlated with temperature (Figure 4C) and daily temperature-azimuth relations showed relatively strong ($R^2 = 0.6$ –0.9) inverse correlations during winter and early spring, corresponding to the time of year when azimuth values and the degree of polarization were greatest (Figure 2C; Supplementary Figure S3). Azimuth was also positively correlated with crack opening following a hysteretic

Crack opening was inversely correlated with air temperature, with maximum crack apertures corresponding to minimum temperatures (Figure 4D). In addition, maximum annual crack opening was not directly in-phase with minimum wintertime temperatures. We assessed the phase shift between daily average temperature and displacement by maximizing the correlation for time lags ranging from 15 to 45 days based on initial guesses from the observed time series (Figure 2D). We found that daily average crack aperture is most strongly correlated with temperature values from 37 days prior (Supplementary Figure S10). We used the annual aperture-temperature regression with a 37-day phase shift to remove the effects of thermally driven signals from observed crack opening (Supplementary Figure S5B). This revealed an increase in net opening of 2.7 mm/year over the 3-year monitoring period during which both frequency and
