# Experimental Investigation of Steel-Borne Acoustic Pulses for Fault Pinpointing in Pipe-Type Cable Systems: A Scaled-Down Model Approach

**Abstract:** Pipe-type cable systems, including high-pressure fluid-filled (HPFF) and high-pressure gas-filled cables, are widely used for underground high-voltage transmission. These systems consist of insulated conductor cables within steel pipes, filled with pressurized fluids or gases for insulation and cooling. Despite their reliability, faults can occur due to insulation degradation, thermal expansion, and environmental factors. As many circuits exceed their 40-year design life, efficient fault localization becomes crucial. Fault location involves prelocation and pinpointing. Therefore, a novel pinpointing approach for pipe-type cable systems is proposed, utilizing accelerometers mounted on a steel pipe to capture fault-induced acoustic signals and employing the time difference of arrival method to accurately pinpoint the location of the fault. The experimental investigations utilized a scaled-down HPFF pipe-type cable system setup, featuring a carbon steel pipe, high-frequency accelerometers, and both mechanical and capacitive discharge

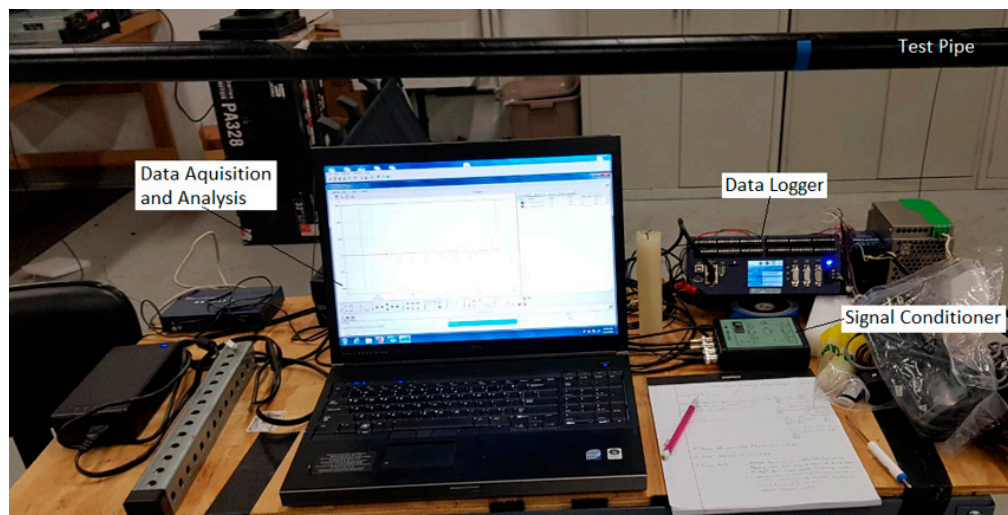
**Figure 1.** Test pipe and measurement system components.

Acoustic pinpointing feasibility testing was conducted on an experimental test pipe consisting of a 19 m long, Schedule-80 carbon steel pipe, (49.25 mm Inner Diameter), the same material used in HPFF pipes. The pipe was coated externally with Pritec (HDPE over butyl mastic; Liberty Coating Company, LLC, Hatfield, PA, USA), the same coating used on HPFF pipes. The pipe's dimensions and material properties are summarized in Table 1. The measurement system included four B&K accelerometers (Brüel & Kjær North America Inc., Duluth, GA, USA), two B&K two-channel signal conditioners, and one Delphin Expert Transient Data Logger (Delphin Technology AG, Bergisch Gladbach, Germany), with specifications provided in Tables 2–4. Figure 1 depicts the test pipe and the components of the measurement system.

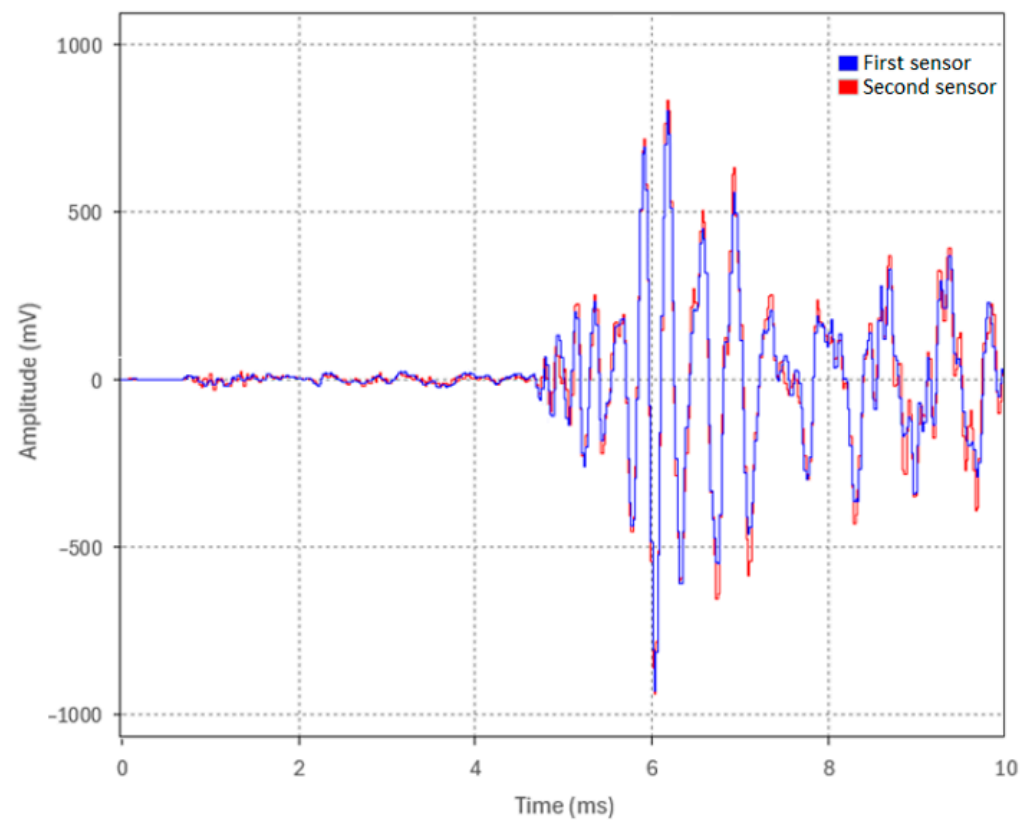
Figure 2. Calibration and time synchronization of two accelerometers.

The B&K accelerometers were individually calibrated by the manufacturer using state-of-the-art random FFT technology, providing an 800-point high-resolution calibration (magnitude and phase). To further verify both calibration and time synchronization, the sensors were mounted together at one end of the pipe while an acoustic pulse was generated by an impact at the opposite end. Since both sensors were at the same location, they should measure an identical pulse timing and amplitude. Figure 2 shows representative waveforms of the acoustic pulse from the first and second sensors, demonstrating their high degree of time synchronization and calibration accuracy in relation to each other. The same verification procedure was performed for the remaining two sensors.

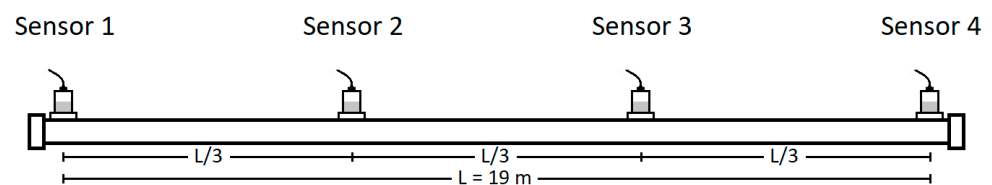
Figure 3. Sensor placements on test pipe (Sensors 1–4).

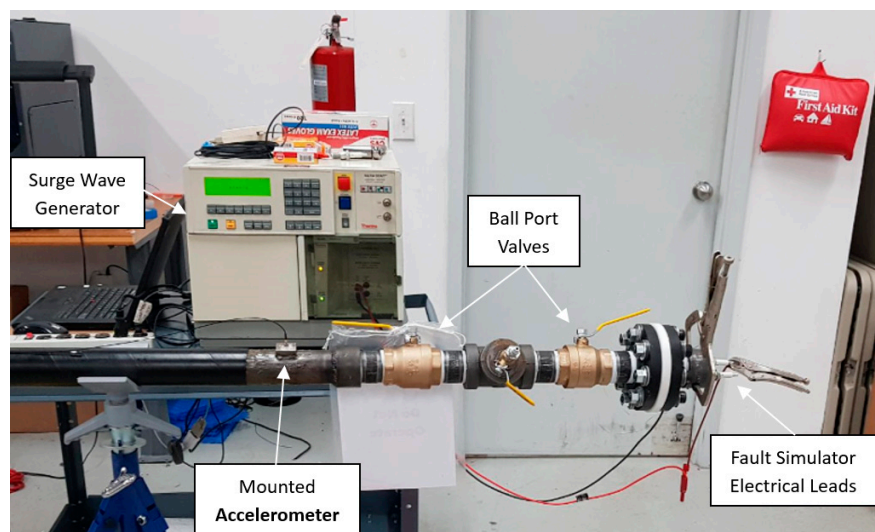
**Figure 4.** Fault simulator device connected to the surge wave generator.

The second method employed a fault simulator device designed to more closely mimic the real-world fault thumping mechanism. This custom-built device comprised a non-resistor spark plug, retrofitted into the dielectric fluid filled as will be detailed in Section 3.2. The terminals of the fault simulator device connect to a surge wave generator or a full-scale thumper, enabling powerful capacitive discharges at the spark gap. The specifications of the full-scale thumper are detailed in Table 5.

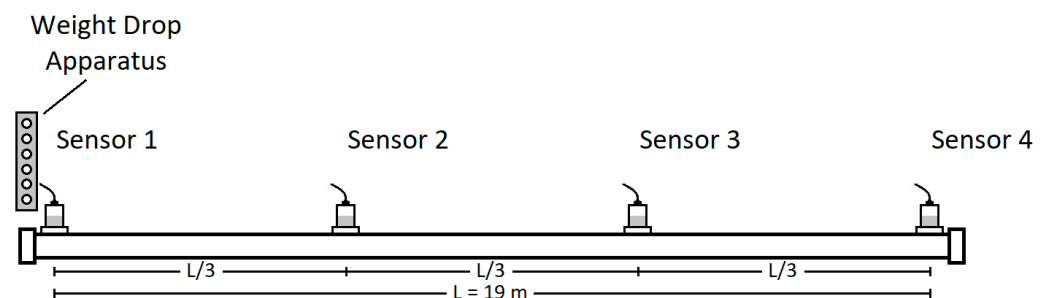
**Figure 5.** Pipe supported in air—Test 3.1 configuration.

In Test 3.1, the test pipe was supported in air using four V-head pipe stands, identical to the setup in Test Series 1 and 2. This test aimed to assess the attenuation of the acoustic pulse solely due to the pipe's properties, serving as a baseline reference for evaluating the additional damping effects observed in Tests 3.2 and 3.3. Figure 5 depicts the setup for Test 3.1, showing the pipe supported in air along with the location of the weight drop apparatus.

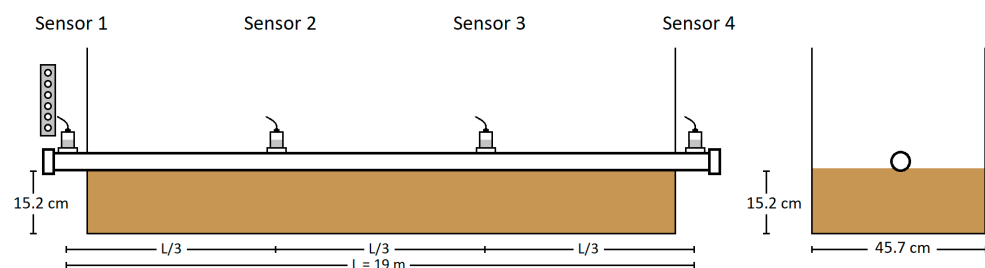
**Figure 6.** Test 3.2 configuration (pipe laid on tamped rock dust)—impact at Sensor 1 location.

For Test 3.2, a containment box measuring 17 m in length, 46 cm in width, and 61 cm in height was constructed from plywood and lined with a vinyl sheet to prevent moisture ingress. Aluminum foil was placed at the bottom of the box to provide grounding for future thumping tests. The pipe was placed on top of the 15 cm thick layer of tamped rock dust, which was added and tamped in 5–8 cm lifts. The overall test layout with the dimensions of the tamped rock dust is shown in Figure 6. The tamping and layering process are depicted in Figure 7a,b, and the final setup is shown in Figure 7c. As in Test 3.1, controlled weight drops were performed using the weight drop apparatus from the same height of 63.5 mm (2.5 in), keeping all parameters consistent except for the pipe now being supported on the tamped rock dust.

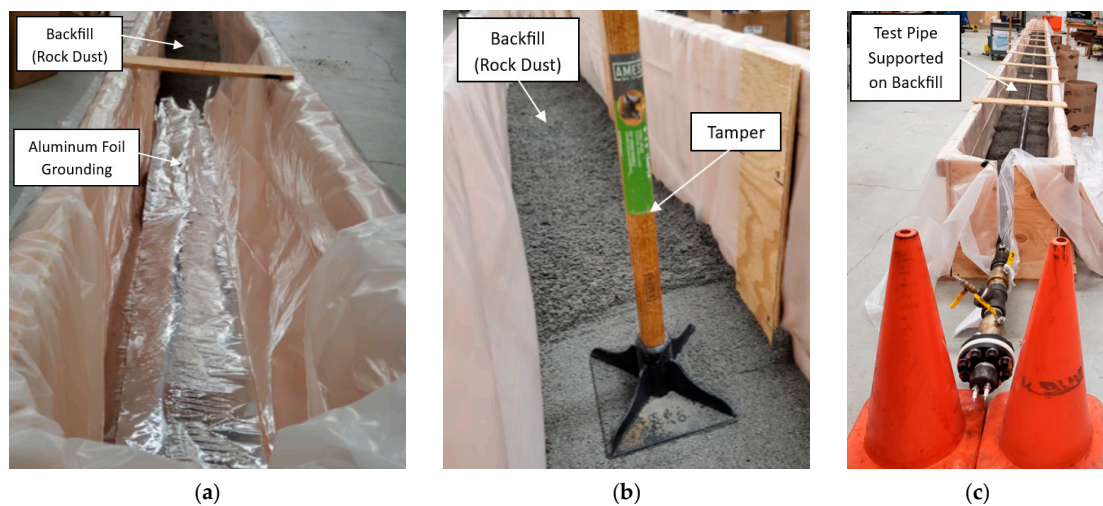
**Figure 7.** Tamping and layering process: (a) rock dust being poured into the containment box; (b) rock dust tamped in 5–8 cm lifts; and (c) final setup of the pipe laid on 15 cm of tamped rock dust in Test 3.2.

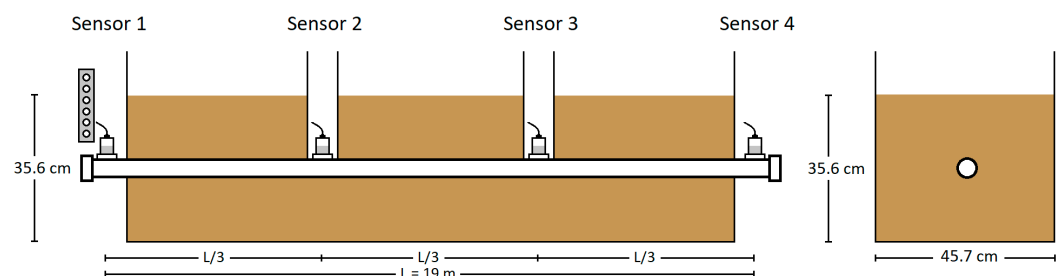
**Figure 8.** Test 3.3 configuration (fully embedded)—impact at Sensor 1 location.

In Test 3.3, additional layers of rock dust were added and tamped until the pipe was fully embedded in the center of the containment box, as shown in Figures 8 and 9a. Access to the intermediate sensors via a ‘manhole’ is shown in Figure 9b. The fully surrounding backfill material (rock dust) provided an absorbing medium for acoustic energy, similar to real pipe-type cable systems. Controlled weight drops were performed using the weight drop apparatus, with all the parameters consistent with those in Tests 3.1 and 3.2, except that the pipe was now fully embedded in the backfill.

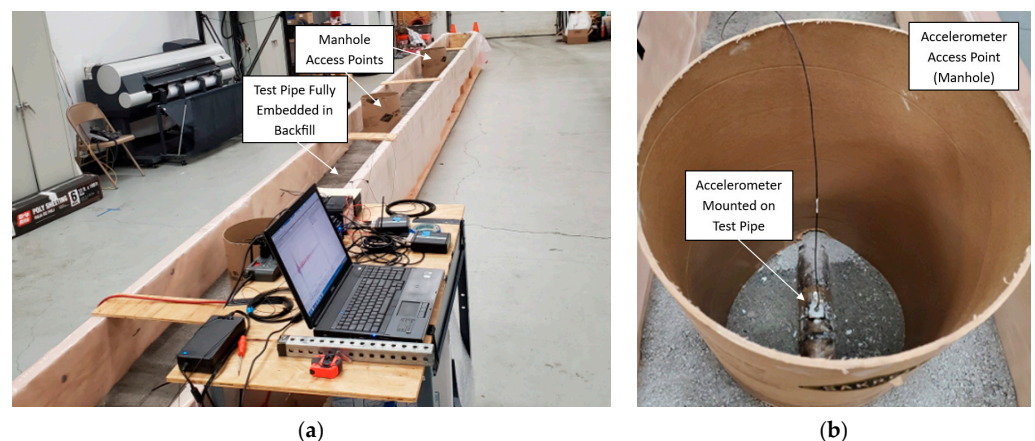
**Figure 9.** Test 3.3—fully embedded configuration: (a) complete experimental setup and (b) manhole access points at intermediate locations for accelerometer placement.

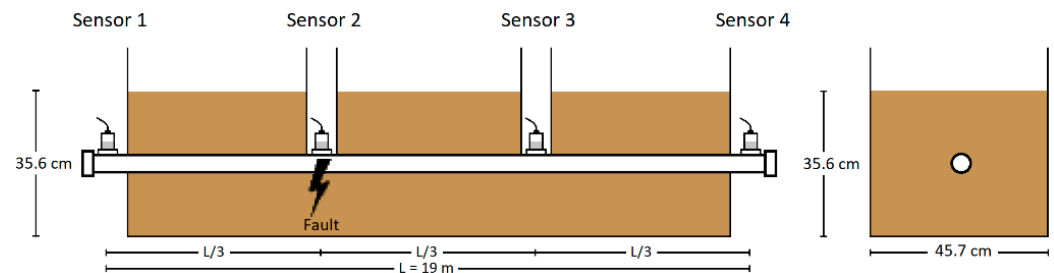
**Figure 10.** Test 4 configuration (fully embedded)—fault simulated at Sensor 2 location.

Test 4 evaluated the acoustic pinpointing method in the fully embedded, dielectric fluid-filled configuration of Test 3.3. The fault simulator was positioned at one-third of the pipe's length (Location 2), as shown in Figure 10, to replicate the common occurrence of faults at an intermediate location in real systems. A full-scale commercial thumper applied a 16 kV voltage charge to generate arcing at the fault. The objective was to assess the acoustic pinpointing effectiveness under conditions simulating an actual HPFF system in a laboratory environment.

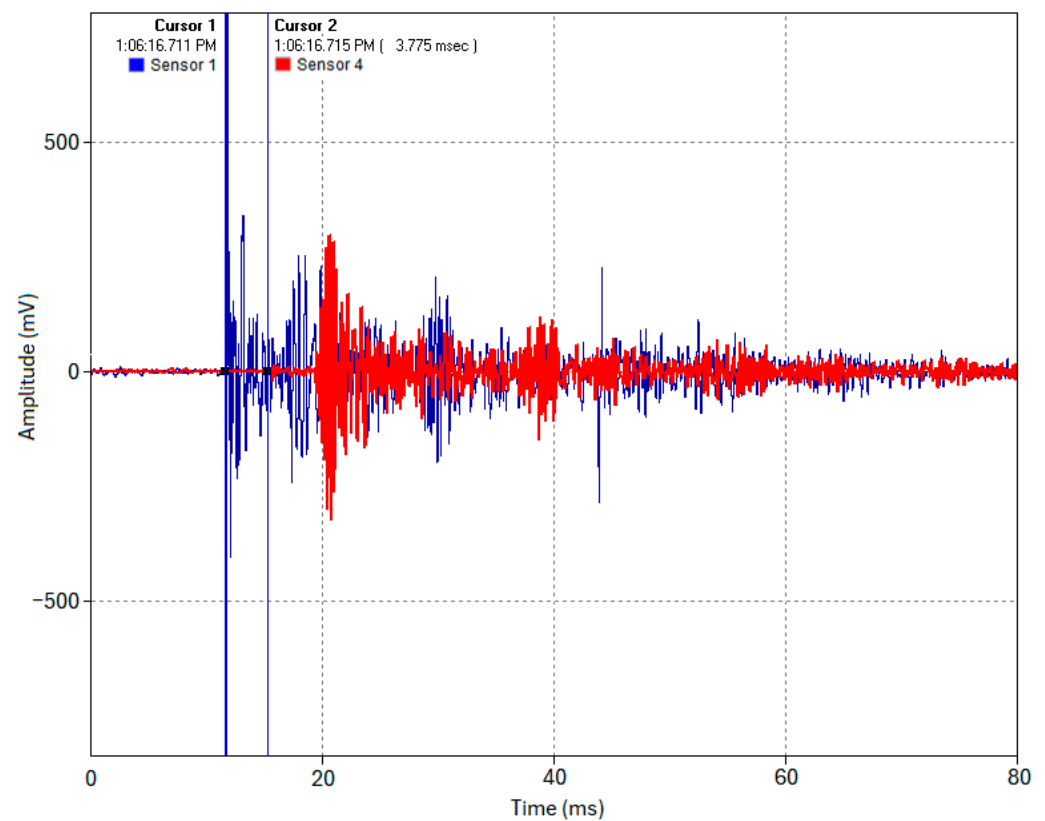
**Figure 11.** Acoustic waveforms captured by Sensors 1 and 4 (Test 1.1).

In Test 1.1, an acoustic pulse was induced at the pipe's end (Location 1). The sensors at Locations 1 and 4 captured the complete waveforms of this acoustic event, as shown in Figure 11. Cursor 1 indicates the timestamp of when the acoustic pulse was induced at Location 1 (Sensor 1, blue trace), and Cursor 2 indicates the timestamp of the time of arrival of the acoustic pulse at Location 4 (Sensor 4, red trace). The acoustic pulse's time of flight across the 19 m pipe was determined using Equation (6) to be approximately 3.75–3.8 ms, as shown in the cross-correlated close-up snapshot in Figure 12. This yields an experimental propagation velocity of 5000–5066.67 m/s, closely matching the theoretical velocity of 5047.7 m/s (calculated using  $E = 200$  GPa and  $\rho = 7850$  kg/m<sup>3</sup> in Equation (2)). Multiple test runs were conducted, and all yielded the same results with a max difference of about 0.1 ms between runs. The slight discrepancy between the test runs can be attributed to high-frequency wave timestamping limitations. While advanced signal processing might reduce this error, the current accuracy is sufficient for this study's proof of concept purpose.

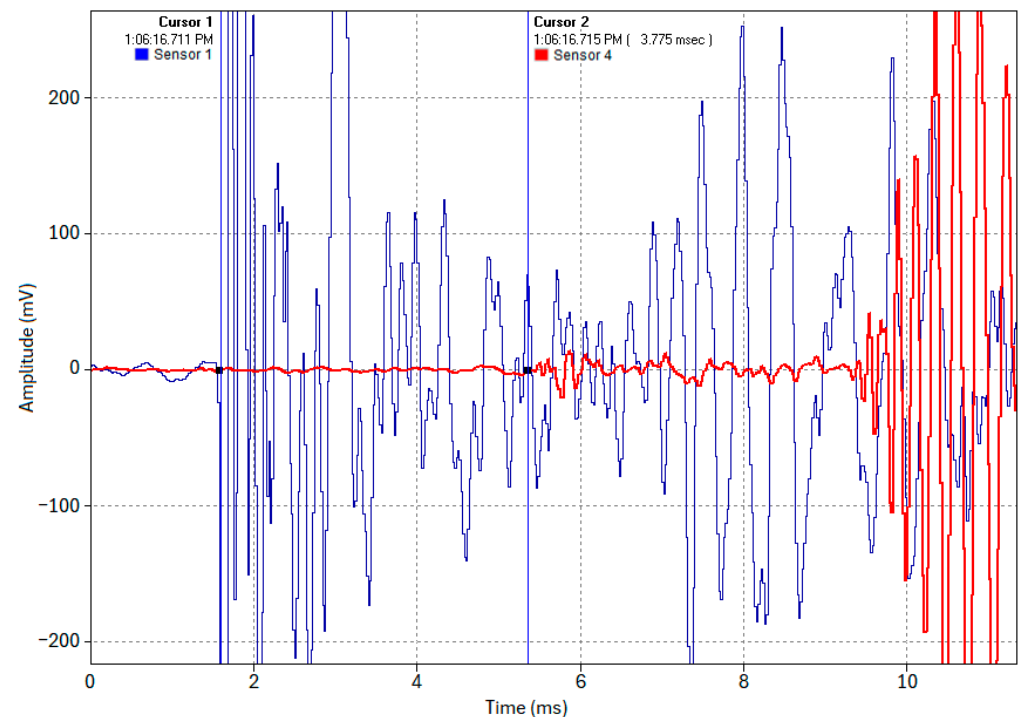
**Figure 12.** Close-up snapshot of the timestamping of the acoustic waveforms captured by Sensors 1 and 4 (Test 1.1).

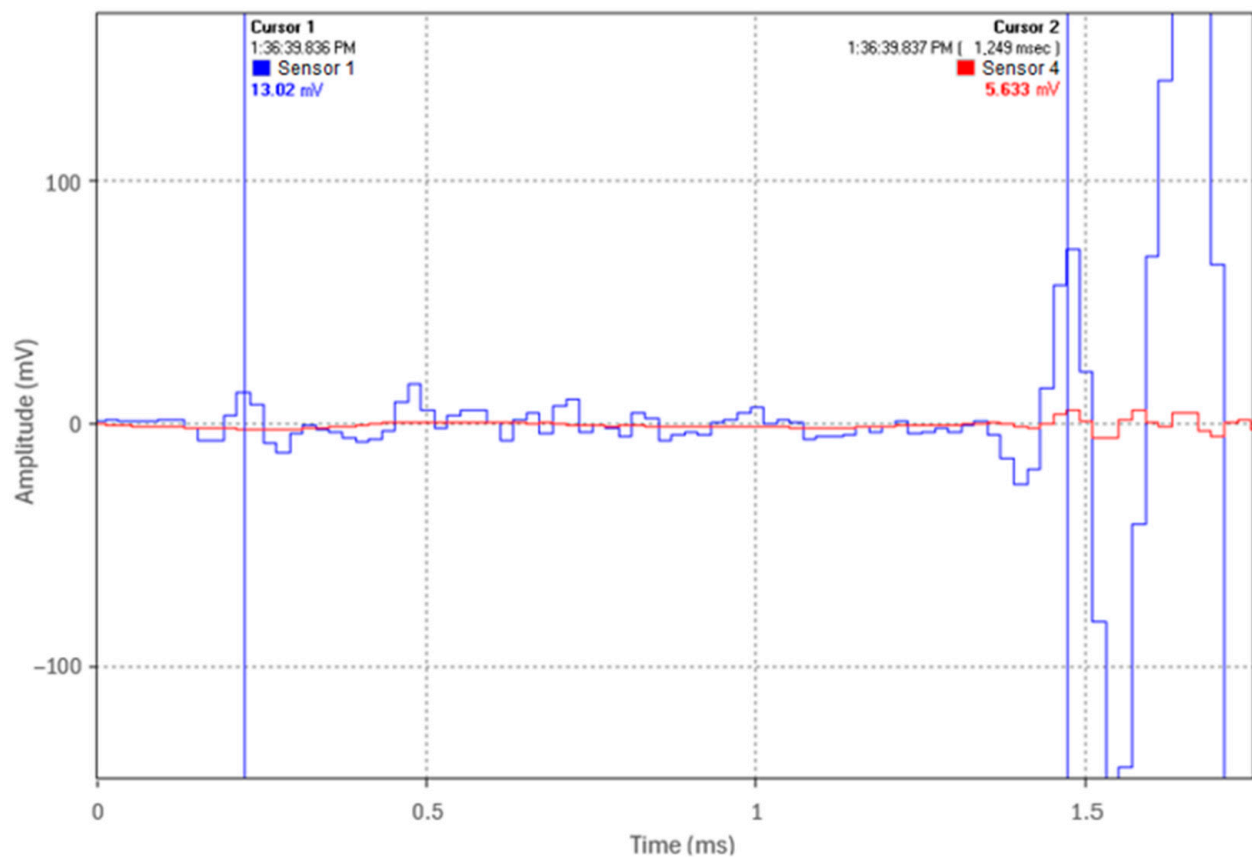
**Figure 13.** TDOA of the acoustic pulse at pipe ends when an acoustic pulse is induced at one-third the length of the pipe (Test 1.2).

In Test 1.2, to evaluate the viability and accuracy of the acoustic pinpointing concept, an acoustic pulse was induced at one-third of the pipe's length (Location 2). Figure 13 illustrates

the TDOA of the acoustic pulse at the pipe ends, which was measured as 1.249 ms. In Figure 13, Cursor 1 indicates the arrival time at Location 1 (Sensor 1, blue trace), while Cursor 2 indicates the arrival time at Location 4 (Sensor 4, red trace).

Using Equation (7), with  $\Delta t = 1.249$  ms,  $v = 5047.7$  m/s, and  $d = 19$  m, the acoustic pulse's origin was calculated to be 6.348 m from Location 1. This closely matches the actual source location of 6.333 m (one-third of the pipe length). The deviation of 1.44 cm, corresponding to only 0.076% of the total pipe length, demonstrates the centimeter-level accuracy achieved in this test. This suggests that if cable thumping generates a sufficiently strong acoustic pulse that propagates along the steel pipe wall and can be detected by remotely positioned sensors, precise fault pinpointing could be achievable.

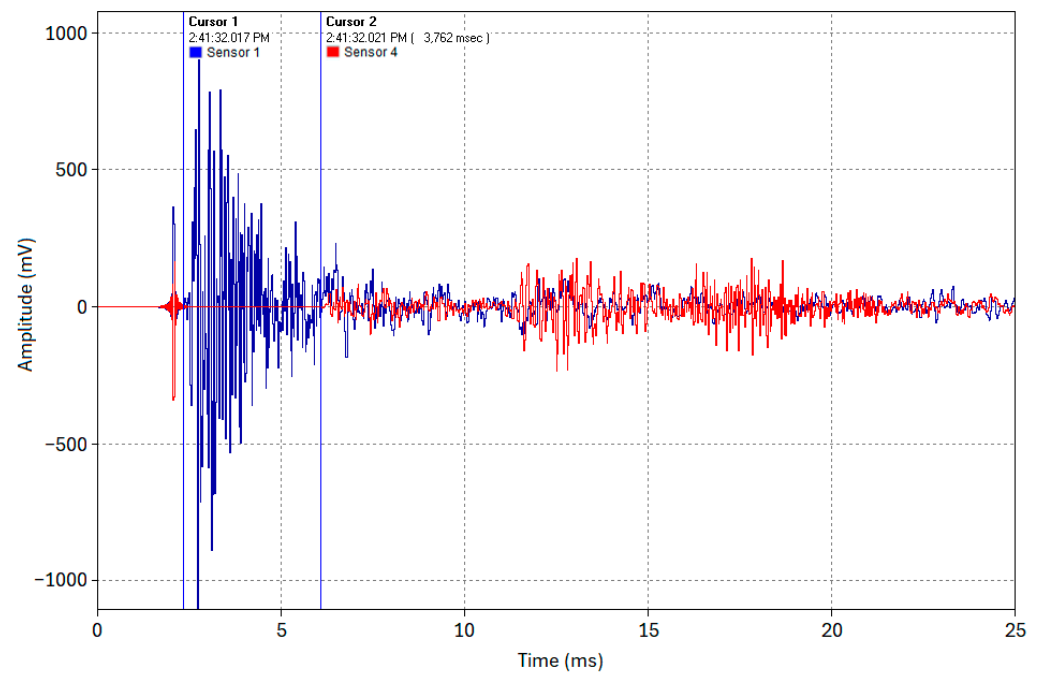
**Figure 14.** Test 2—blue waveform (Sensor 1); red waveform (Sensor 4).

Test 2 involved creating an arc (spark) in the dielectric fluid inside the pipe at Location 1, simulating the arcing mechanism that occurs at the fault location when a cable is thumped. The waveforms recorded by the sensors installed at the pipe ends are shown in Figure 14. The results demonstrate that a capacitive discharge in the dielectric fluid not only creates a hydraulic pressure transient but also induces an acoustic pulse, which propagates along the steel pipe wall. This test further validates the acoustic fault pinpointing concept, confirming that thumping a real HPFF pipe-type cable system will very likely induce an acoustic pulse at the fault's location. The acoustic pulse time of flight across the 19 m pipe was 3.76 ms, consistent with that derived in Test 1.1. This consistency was expected since the acoustic velocity depends on the propagation medium, regardless of the generation method.

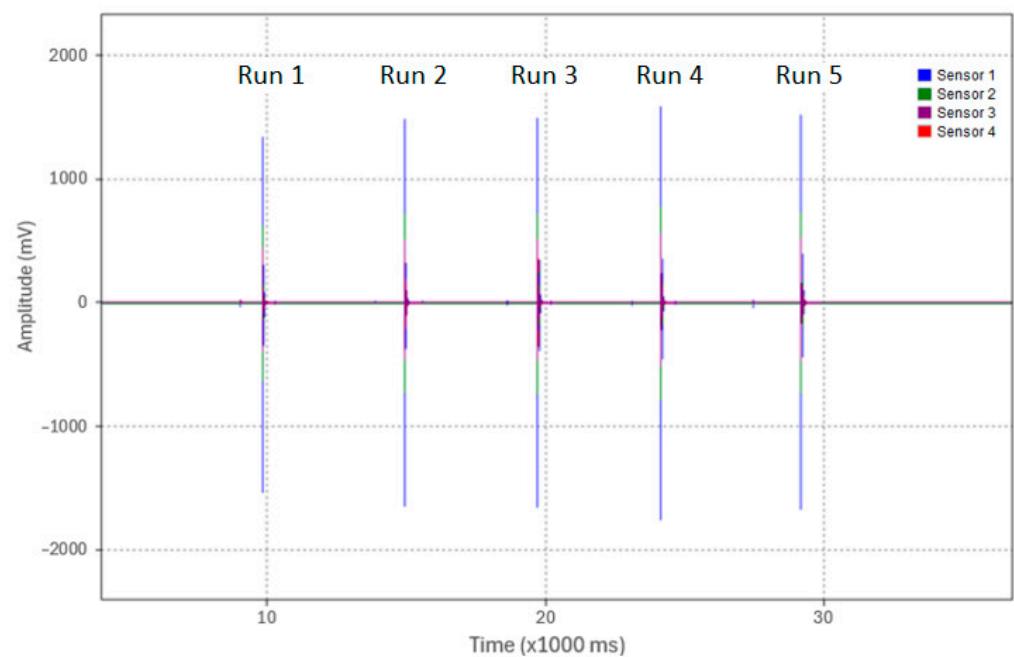
**Figure 15.** Overview of peak amplitudes from Sensor 1 for the five test runs of Test 3.1.

In Test 3.1, the pipe was supported in air similar to in the previous tests. An acoustic pulse was induced at the pipe end (Location 1) via the weight drop apparatus (0.91 kg dropped from a 63.5 mm height). Five identical test runs were conducted from the same height with a 3 kHz LPF applied to the experimental data. An overview of the five test runs is shown in Figure 15 and the waveforms of Test 1—Run 1 as acquired by the four sensors are shown in Figure 16. The waveform peak amplitudes from Sensors 1, 2, 3, and 4, as labeled in Figure 16, were recorded for all five runs and were tabulated in Table 7.

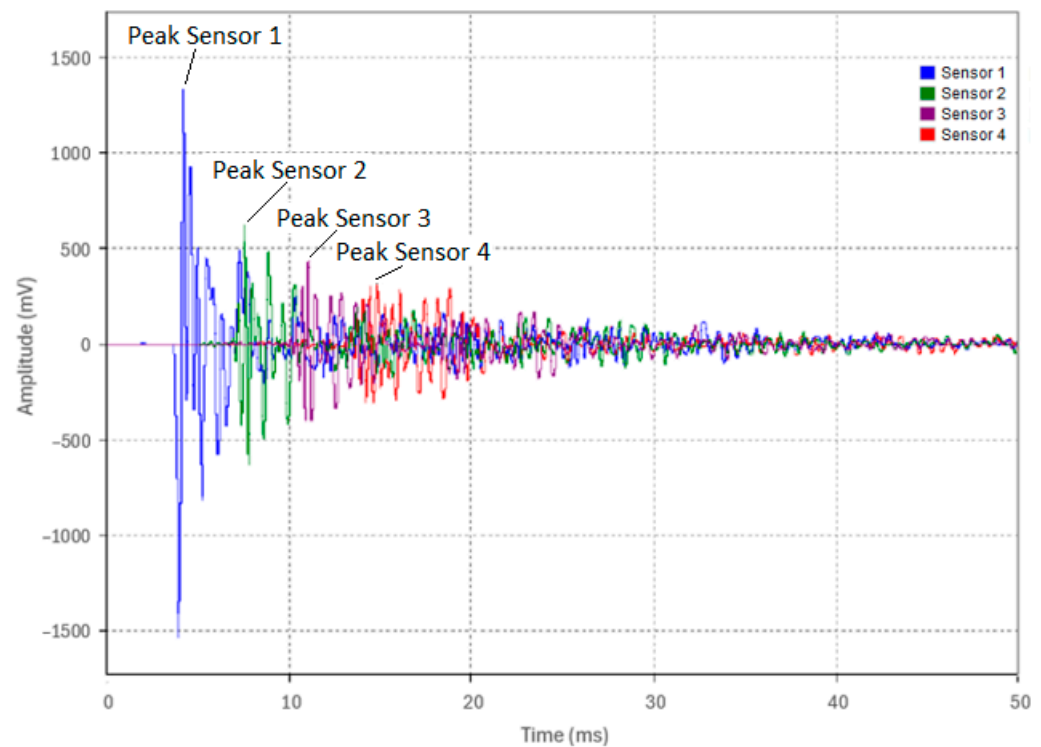
**Figure 16.** Captured waveforms from Sensors 1, 2, 3, and 4 for Run 1 in Test 3.1.

The attenuation of the acoustic pulse is evident, as shown in Figure 16 and summarized in Table 7. Table 7 also shows that the peak amplitudes between runs were consistent, confirming the reliability of the excitation method and the repeatability of the test setup. Using Equation (5), the attenuation coefficient between each sensor pair was calculated in Np/m and is presented in Table 7. The peak amplitude decreased by approximately 52% from Sensor 1 to Sensor 2, 29% from Sensor 2 to Sensor 3, and 31% from Sensor 3 to Sensor 4. This pattern of attenuation was consistent across all five test runs.

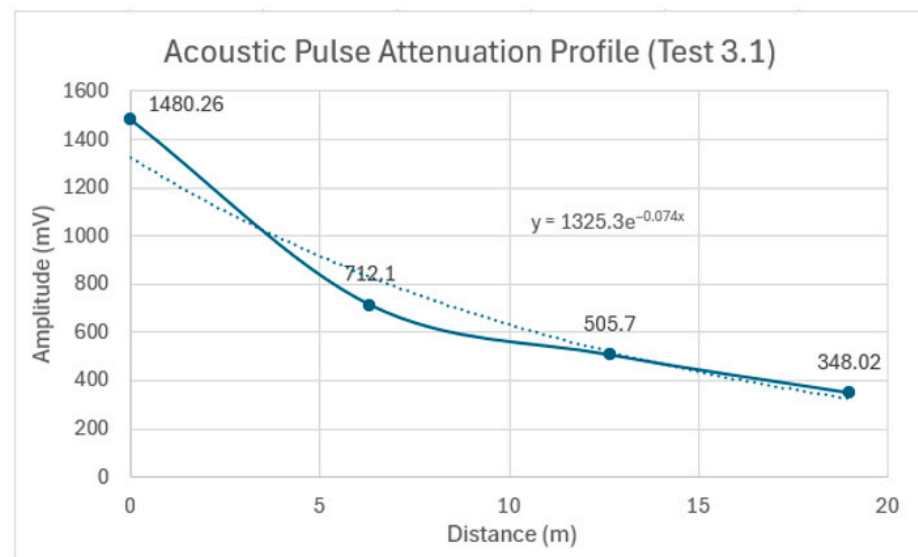
**Figure 17.** Acoustic pulse attenuation profile as it propagates along the 19 m pipe in Test 3.1: the solid line connects the data points, and the dotted line shows an exponential trendline that best fits the overall attenuation.

To determine the overall attenuation over the entire 19 m pipe, the average peak amplitude from each of the four sensors was plotted in Figure 17. This figure illustrates how the signal's peak value attenuates as it propagates along the length of the pipe. The overall attenuation coefficient, determined to be 0.074 Np/m from the power of the exponential function in the trendline equation, will serve as a reference for assessing the added attenuation due to pipe embedment in the subsequent tests.

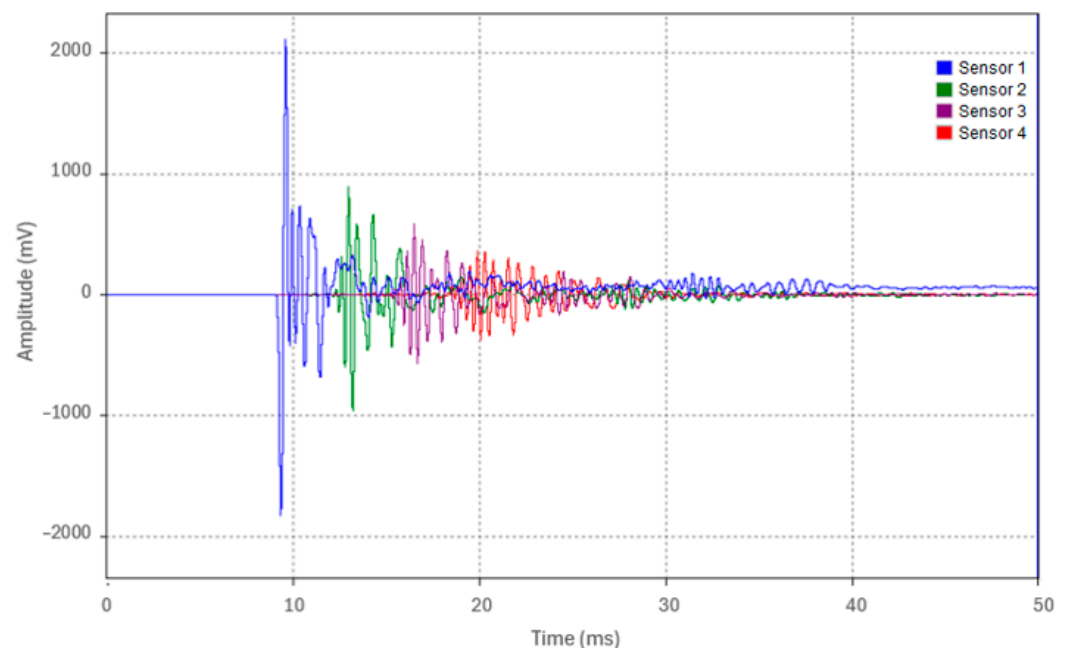
**Figure 18.** Waveforms from the four accelerometers of Run 1 in Test 3.2.

The attenuation of the acoustic pulse is evident, as shown in Figure 18 and summarized in Table 8. The percentage decrease in the peak amplitude was approximately 56.7% from Sensor 1 to Sensor 2, 35% from Sensor 2 to Sensor 3, and 38.2% from Sensor 3 to Sensor 4. Figure 19 depicts the overall attenuation of the acoustic pulse as it propagates along the 19 m pipe. The overall attenuation coefficient for Test 3.2 was measured at 0.09 Np/m. A slight increase in the attenuation coefficient of approximately 0.016 Np/m was observed between Tests 3.1 and 3.2. This increase is attributed to the pipe's contact with tamped backfill, which resulted in minor acoustic energy leakage.

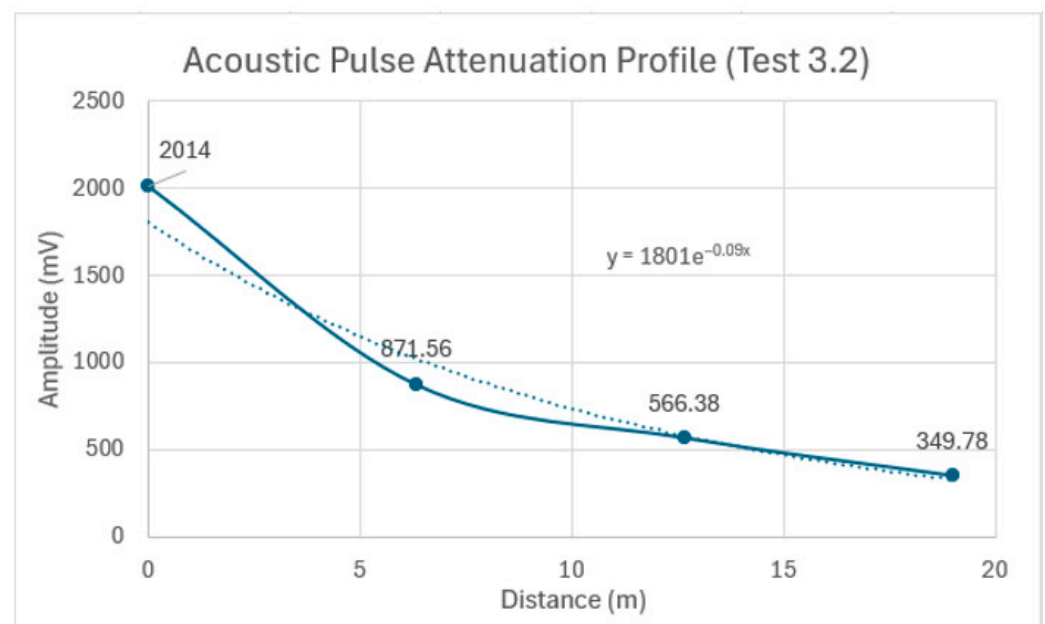
**Figure 19.** Acoustic pulse attenuation profile as it propagates along the 19 m pipe in Test 3.2: the solid line connects the data points, and the dotted line shows an exponential trendline that best fits the overall attenuation.

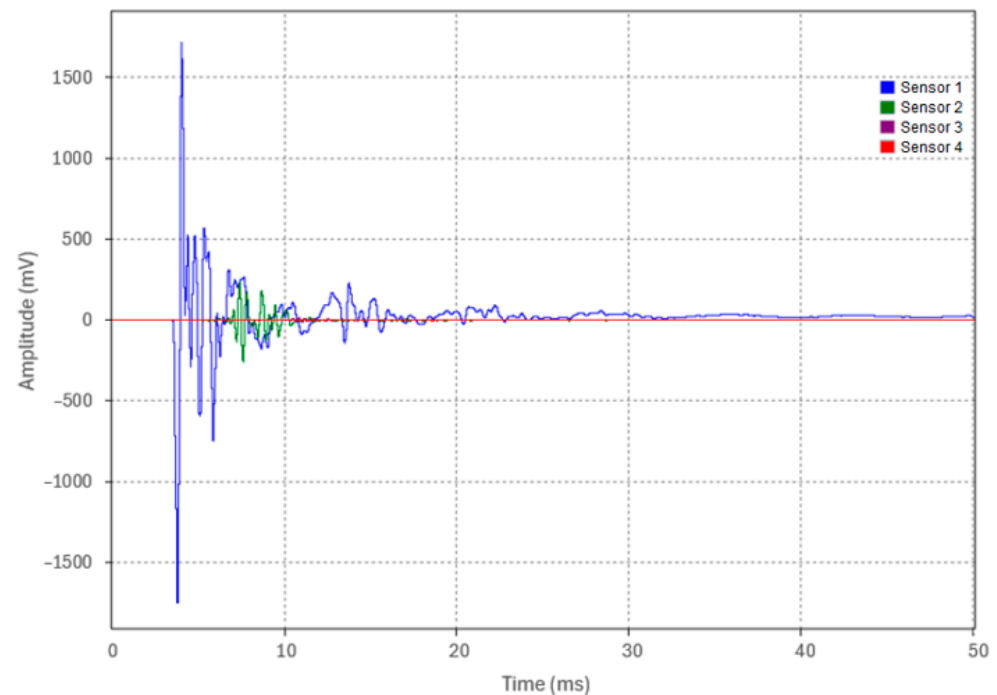
**Figure 20.** Waveforms from the four accelerometers of Run 1 in Test 3.3.

An analysis of the Test 3.3 data in Table 9 indicates that the percentage decrease in the peak amplitude was approximately 86% from Sensor 1 to Sensor 2, increasing to 94.3% from Sensor 2 to Sensor 3, and measuring at 66.9% from Sensor 3 to Sensor 4. The overall average attenuation across the 19 m embedded pipe for Test 3.3 was calculated to be 0.327 Np/m, as

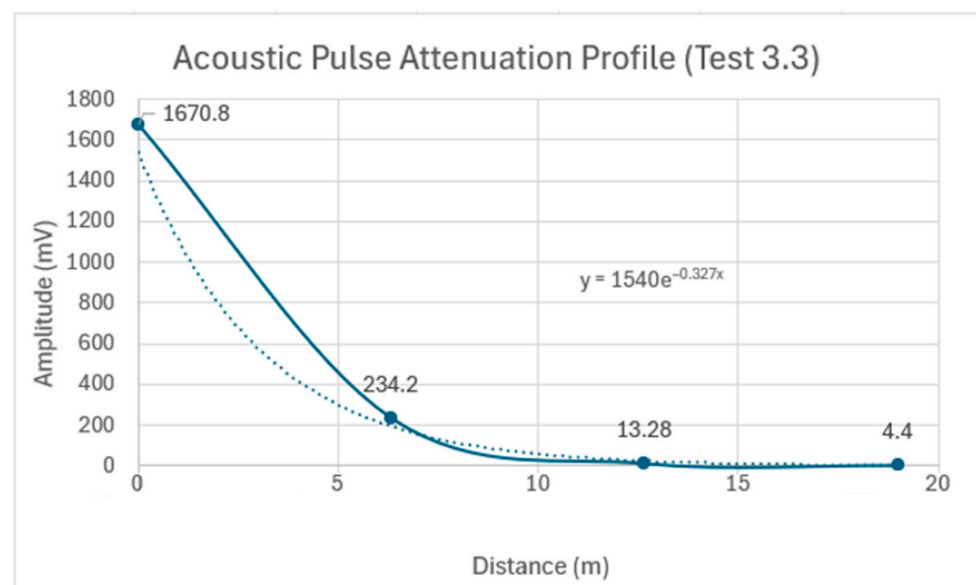
**Figure 21.** Acoustic pulse attenuation profile as it propagates along the 19 m pipe in Test 3.3: the solid line connects the data points, and the dotted line shows an exponential trendline that best fits the overall attenuation.

shown in Figure 21. An increase in the attenuation coefficient of approximately 0.237 Np/m was observed between Tests 3.2 and 3.3. This increase is attributed to the transition from the partial backfill contact at the pipe's bottom surface in Test 3.2 to complete backfill embedment around the pipe's circumference in Test 3.3, resulting in significant acoustic energy leakage into the surrounding medium. The data demonstrate that the acoustic pulse amplitude decreased from an initial 1670 mV to 4.7 mV after propagating the entire 19 m pipe length. However, despite this substantial reduction, the pulse remained clearly detectable after traveling 19 m, highlighting the potential viability of this method for long-distance acoustic pulse detection in fully embedded pipe conditions.

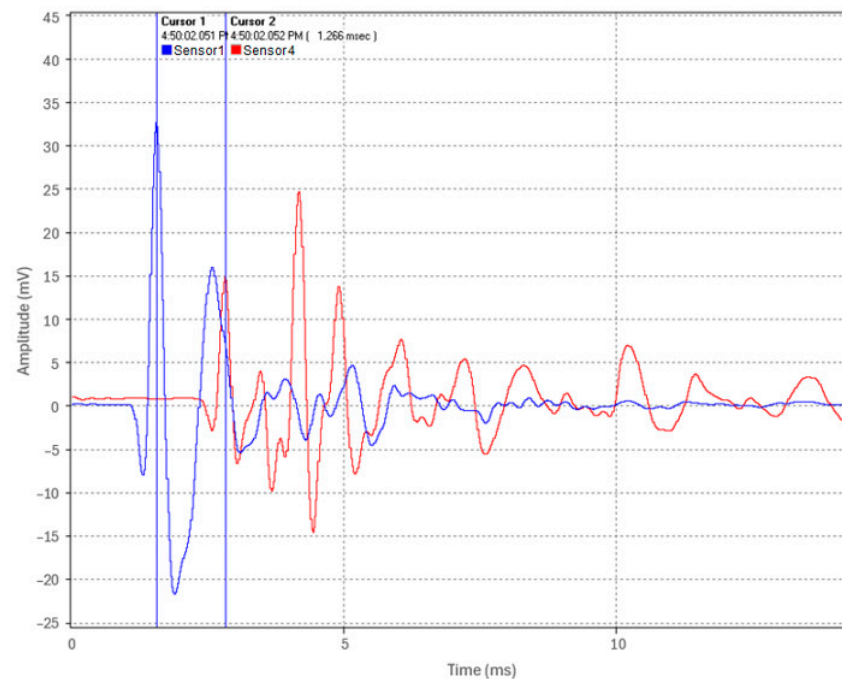
**Figure 22.** Fault-induced acoustic pulse waveform captured by Sensors 1 and 4 (Test 4).

Following the assessment of the backfill material's impact on acoustic pulse attenuation, we confirmed that a low-amplitude pulse generated by the weight drop apparatus remained detectable after propagating 19 m in the fully embedded pipe. Subsequently, a test was conducted using a fault simulator and a full-scale commercial thumper, which applied a 16 kV voltage charge to simulate a fault thumping event at one-third of the pipe's length (Location 2). Figure 22 shows the acoustic pulse waveform recorded by the time-synchronized sensors at the pipe's ends (Sensor 1 in blue and Sensor 4 in red).

The results of the fault simulator test on the fully embedded pipe indicate that even when the test pipe is fully embedded in backfill, the instrumentation package can readily detect and timestamp the acoustic pulse waveform generated at the fault's location using sensors positioned remotely (Figure 22). A time of arrival difference of 1.266 ms was deduced between Sensors 1 and 4. Using Equation (2), with  $\Delta t = 1.266$  ms,  $v = 5047.7$  m/s, and  $d = 19$  m, the fault-induced acoustic pulse origin was calculated to be 6.305 m from the pipe's end (Location 1). This result closely aligns with the actual fault location at 6.333 m (one-third of the pipe length).
